Investigation of Mould Growth

Cabin 1 and 6

1225 Grass Lake Road, Haliburton, Ontario

August 27, 2021

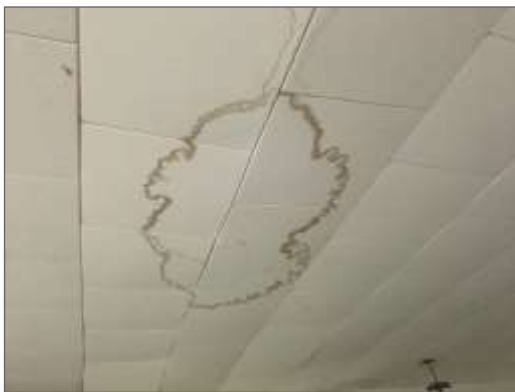
Photo 1 - Typical water staining identified on 1x1 tiles in various locations throughout the cabin.

A total of 25 water damaged ceiling tiles were identified, cracking in walls was seen by windows in various locations. Organic growth identified on the roof of the cabin, and ~10 sqft of wet wall identified by the front entrance.

Water damage and wet materials were identified in Cabin 1, consisting of 25 water damaged ceiling tiles and ~12sqft of wet wall by the front entrance.

The water damage and wet materials identified Cabin 1 was likely caused by building envelope issues. Full inspection of attic space was not possible through the small access hatch.

4. Sample suspect asbestos containing drywall joint compound prior to its removal.
5. Inspect roof and or above ceiling to identify the cause of water damaged ceiling tiles in Cabin 1 and make any necessary repairs.

- a. Remove the lower 2ft of drywall in the living area (~12sqft) where indicated to be wet on the drawings in Appendix I.
8. Remove and dispose of water damaged ceiling tiles in Cabin 1 following EACC Level 1 methods.
9. Finalize an inspection and testing plan to document the mould remediation. To confirm, Pinchin will perform inspections at the following stages:
 - a. Clean Site Preparation
 - b. Post-Remediation Inspection
10. Clean the floors, other building surfaces, furnishings and contents in areas immediately adjacent to the remediation work areas, following normal custodial practices.

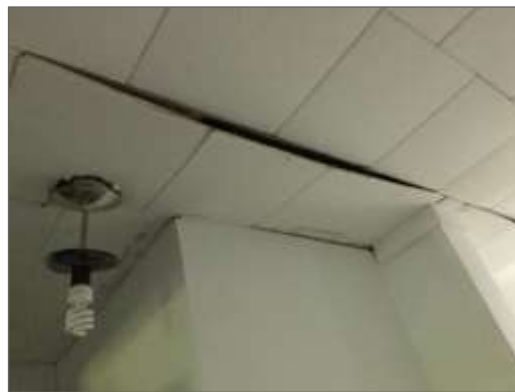
Photo 2 - Ceiling falling in, in corridor of Cabin.

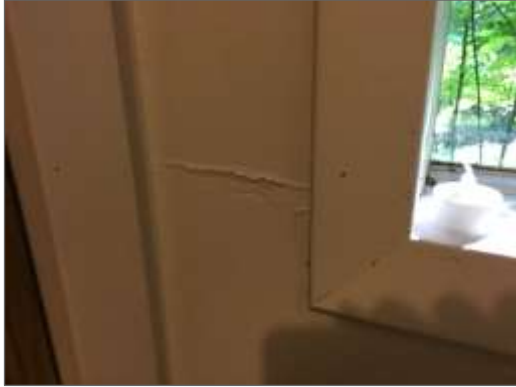
Photo 3 - Cracks in drywall could be due to building shift or past water infiltration.

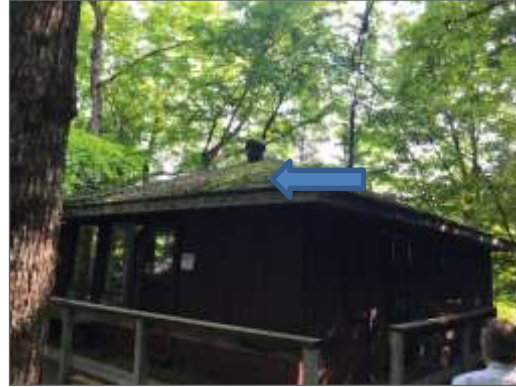
Photo 4 - Organic growth on Cabin roof

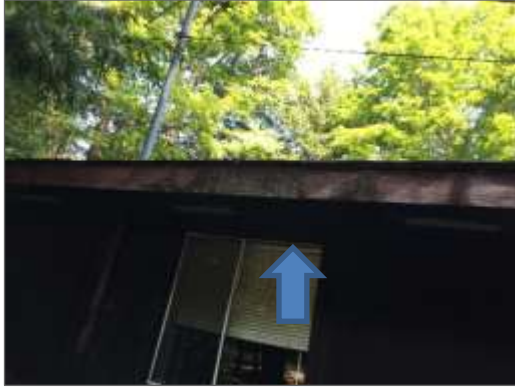
Photo 5 - Potential growth on wood below roof.

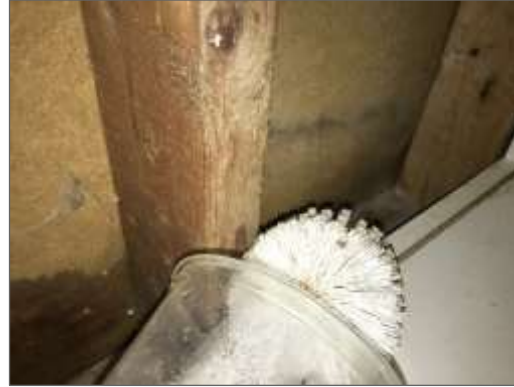
Photo 6 - Mould growth on wood fibre panel identified in closet area

Mould growth on wood fiber paneling behind the drywall wall that was changed out after a past water damage incident. ~30sqft of mould growth identified. Drywall in washroom is wet by toilet and another ~10sqft of mould growth was identified.

Water damage, mould growth and wet materials were identified in Cabin 6, consisting of ~40sqft of mould growth and 10sqft of wet drywall in the washroom and utility closet.

- a. Remove the lower 2ft of wood fibre board panelling and drywall in the washroom and closet (~50sqft) where indicated to be wet or mouldy on the drawings in Appendix I.

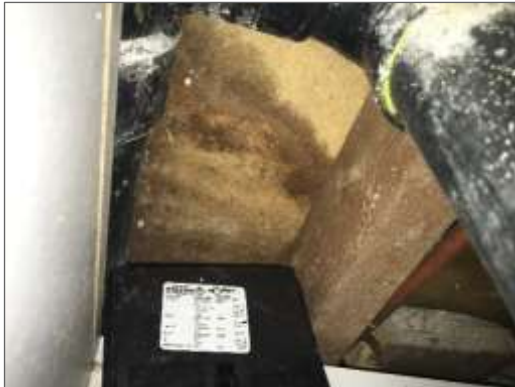
Photo 7 - Mould growth on wood fibre panel behind kitchen sink drywall that was replaced.

The water damage, mould growth and wet materials identified Cabin 6 was likely left from the repair of the leaking sink from the kitchen, and from a possible leak, overflow or running toilet.

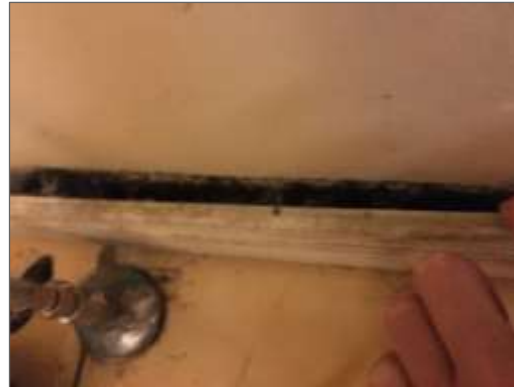
Photo 8 - Mould growth behind loose baseboard in washroom.
