Investigation of Mould Growth

Cabins 1-8

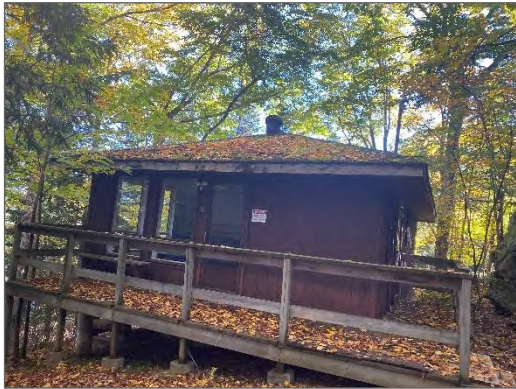
Temperature	11.7 °C	Extent of Mould Growth	200 ft ²
Relative Humidity	50.6 %RH	Extent of Water Damage Including Mould Growth	240 ft ²

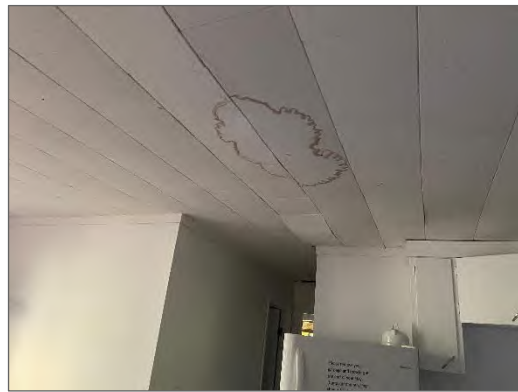
Photo 4 - Typical water staining identified on 1x1 tiles in various locations throughout the cabin.

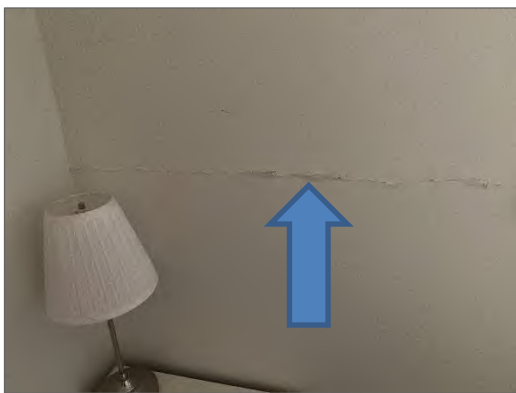
Photo 5 - Cracks in drywall walls due to building shift.

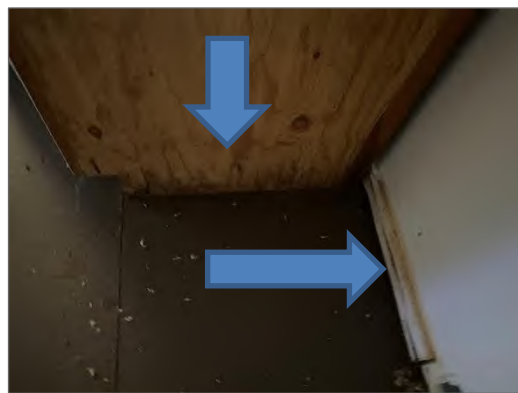
Photo 6 - Water damage on lower part of wood cabinets and slight mould growth on drywall (TL-01) where stove would go.

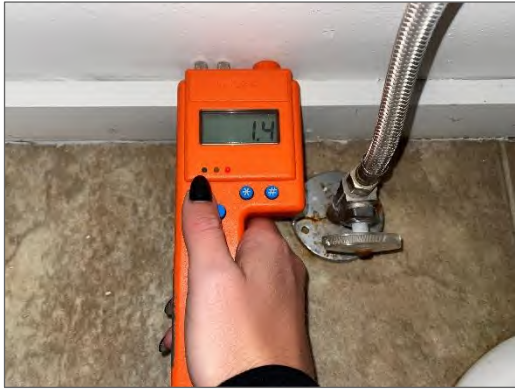
Photo 7 - Wet wall behind toilet in Washroom.

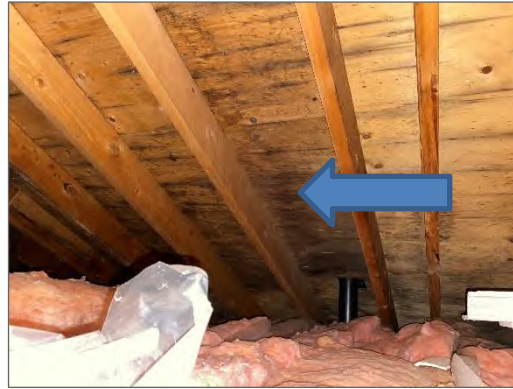
Photo 8 - Typical spotting observed in attic space.

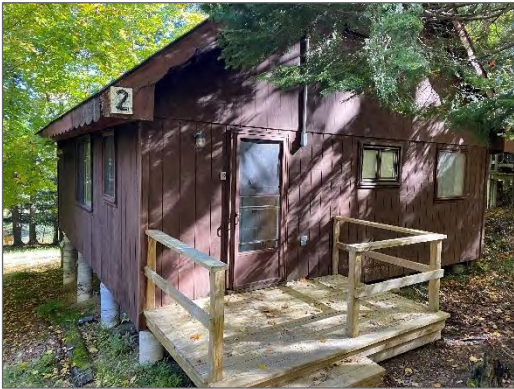
Temperature	7.6 °C	Extent of Mould Growth	15 ft ²
Relative Humidity	63.2 %RH	Extent of Water Damage Including Mould Growth	20 ft ²

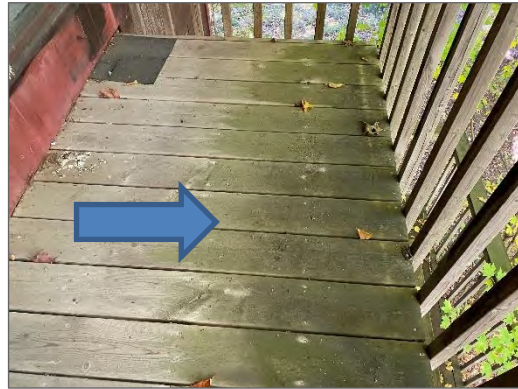
Photo 10 - Organic growth/water damage on balcony.

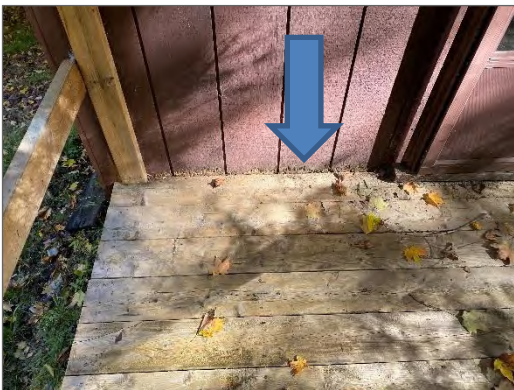
Photo 11 - Lower part of wood exterior panelling is starting to rot.

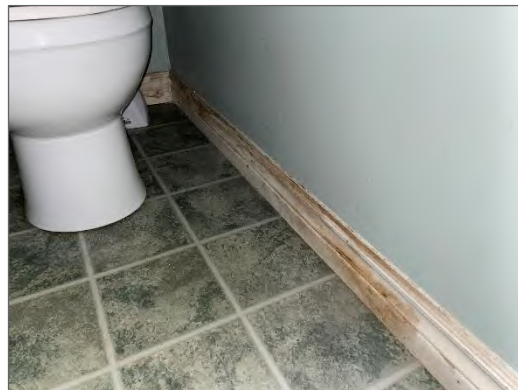
Photo 12 - Water staining on baseboard (TL-02).

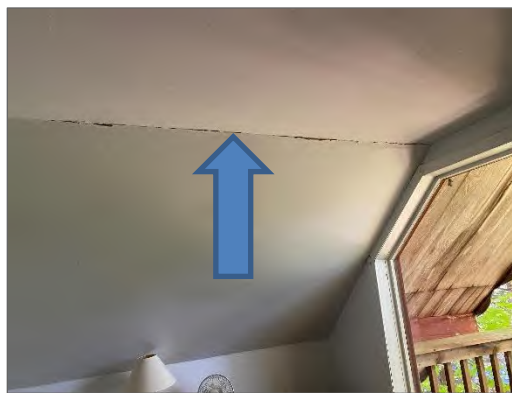
Photo 13 - Cracks in drywall due to building shift.

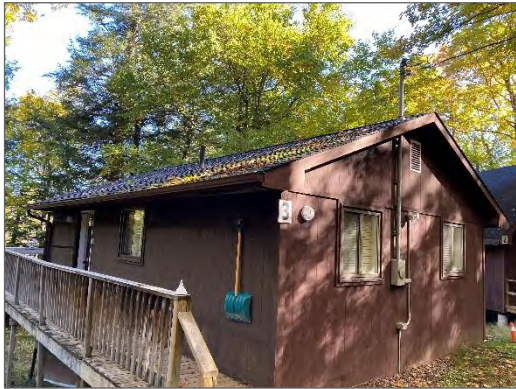
Temperature	20.4 °C	Extent of Mould Growth	105 ft ²
Relative Humidity	50.7 %RH	Extent of Water Damage Including Mould Growth	105 ft ²

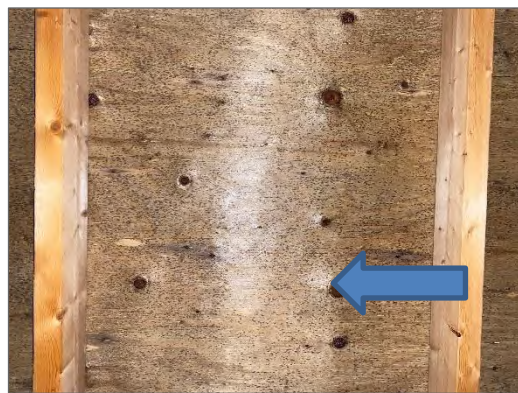
Photo 19 - Typical spotting observed on side walls of attic space.

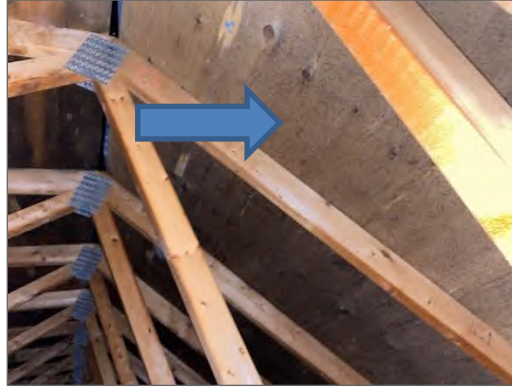
Photo 20 - Typical spotting observed on side walls of attic space.

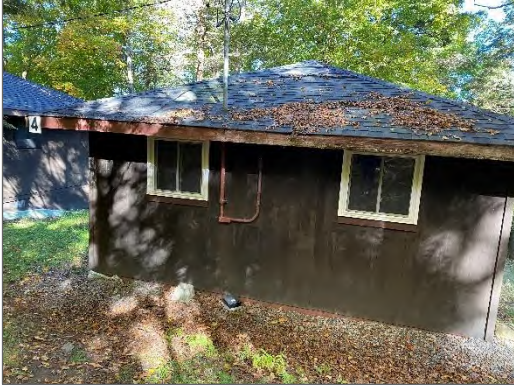
Temperature	17.8 °C	Extent of Mould Growth	152 ft ²
Relative Humidity	58.6%RH	Extent of Water Damage Including Mould Growth	166 ft ²

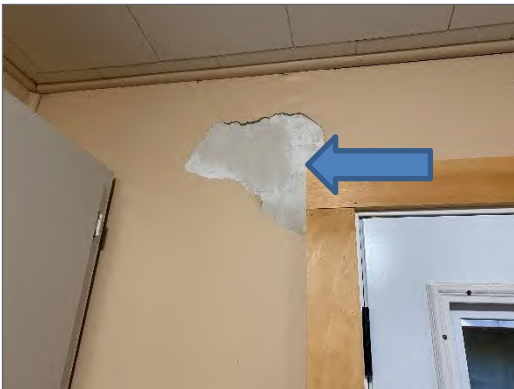
Photo 23 - Water damage by exterior door.

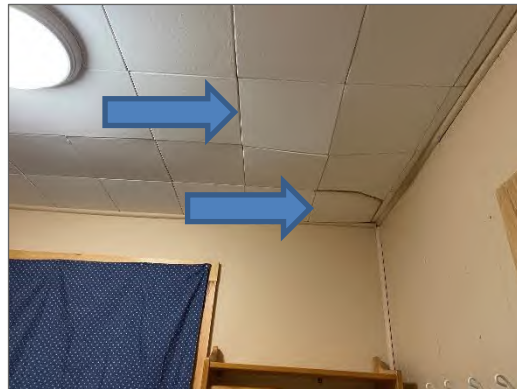
Photo 24 - Water stained ceiling tile and ceiling falling in.

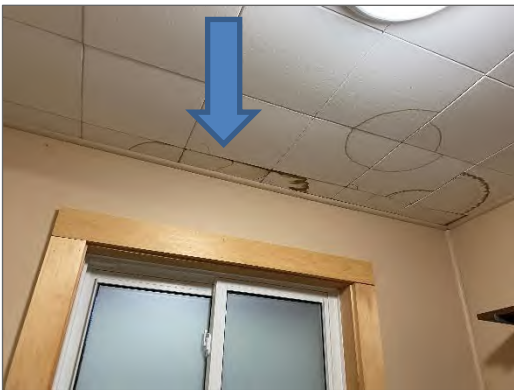
Photo 25 - Typical water stained ceiling tiles identified throughout cabin.

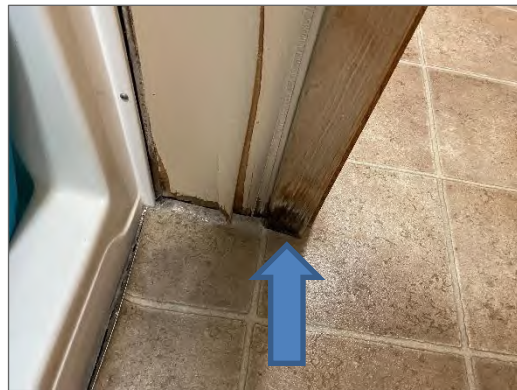
Photo 26 - Black spotting on wooden door frame and damage to wood panelling by shower confirmed mould (TL-08).

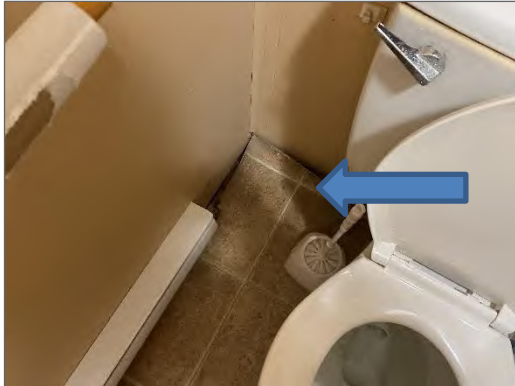
Photo 27 - Flooring by toilet is lifting due to water damage.

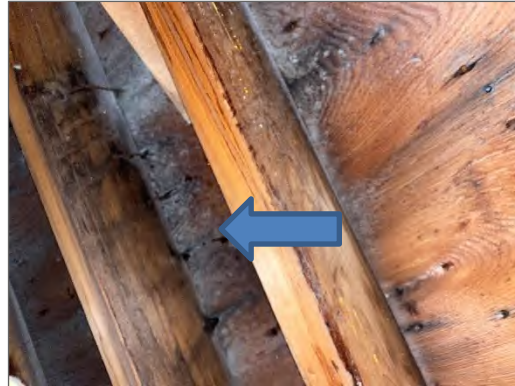
Photo 28 - Spotting identified on wood in attic space on all sides.

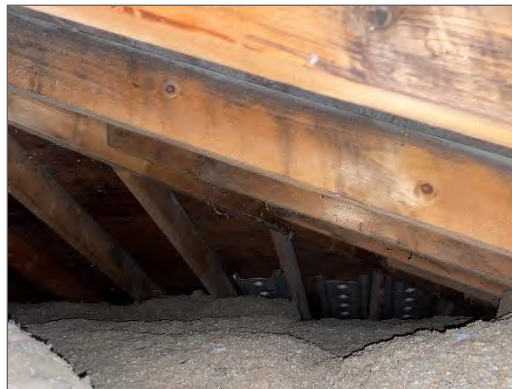
Photo 29 - Spotting identified on wood in attic space on all sides.

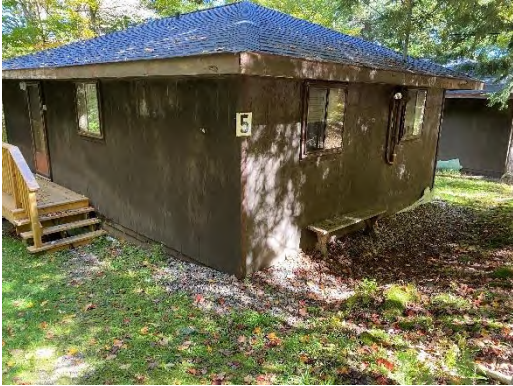
Temperature	8.1 °C	Extent of Mould Growth	160 ft ²
Relative Humidity	75.2 %RH	Extent of Water Damage Including Mould Growth	210 ft ²

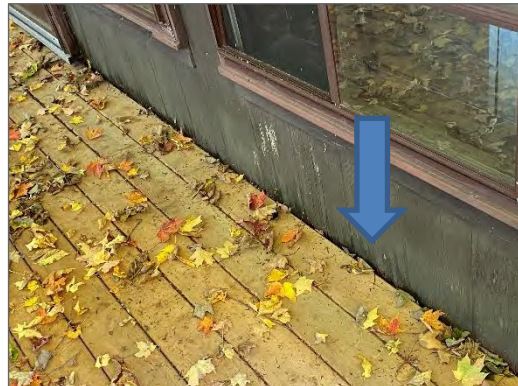
Photo 31 - Exterior wood siding is beginning to rot due to water.

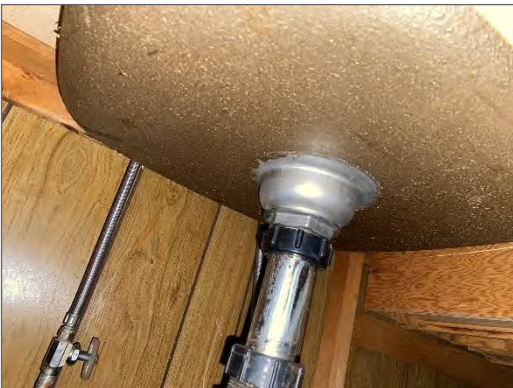
Photo 32 - Asbestos containing sink mastic on sink in Kitchen.

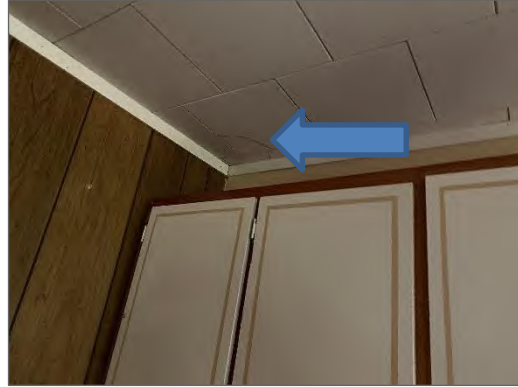
Photo 37 - Typical water stained ceiling tiles identified throughout cabin.

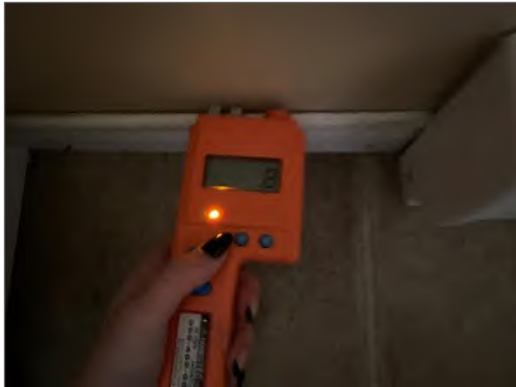
Photo 38 - Wet wall identified behind toilet.

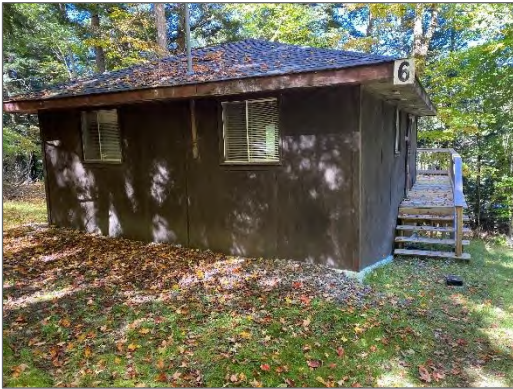
Temperature	9.0 °C	Extent of Mould Growth	155 ft ²
Relative Humidity	77.8 %RH	Extent of Water Damage Including Mould Growth	170 ft ²

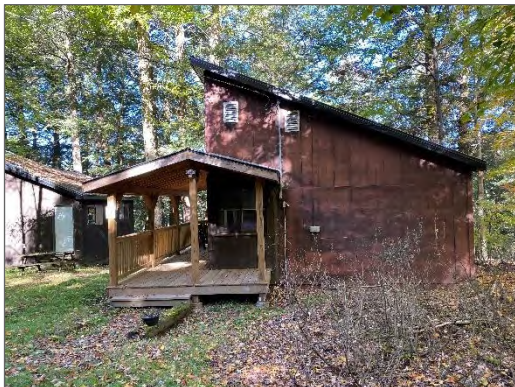
Temperature	16.6 °C	Extent of Mould Growth	10 ft²
Relative Humidity	60.5 %RH	Extent of Water Damage Including Mould Growth	15 ft²

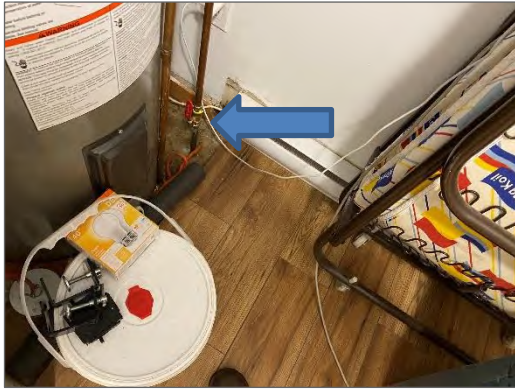
Photo 49 - Water damage behind hot water tank.

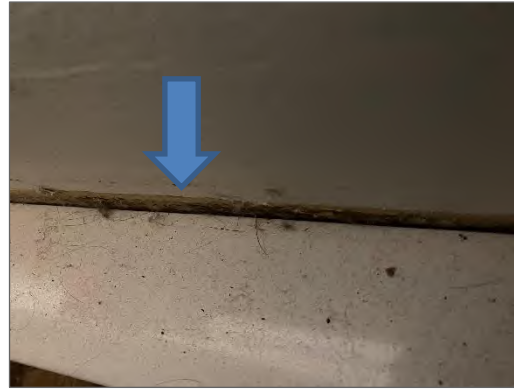
Photo 50 - Black spotting behind baseboard radiator in bedroom.

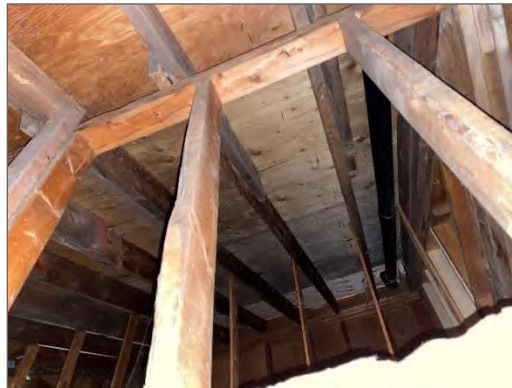
Photo 51 - No suspect mould identified in attic space.

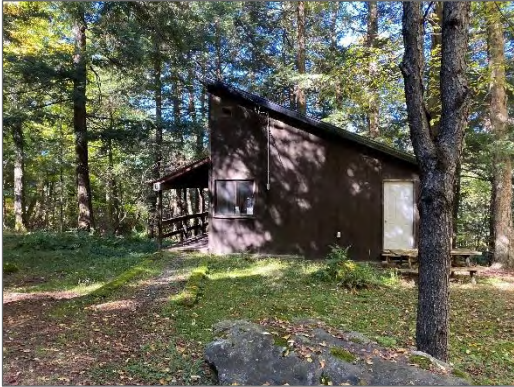
Temperature	14.9 °C	Extent of Mould Growth	20 ft ²
Relative Humidity	56.2 %RH	Extent of Water Damage Including Mould Growth	50 ft ²

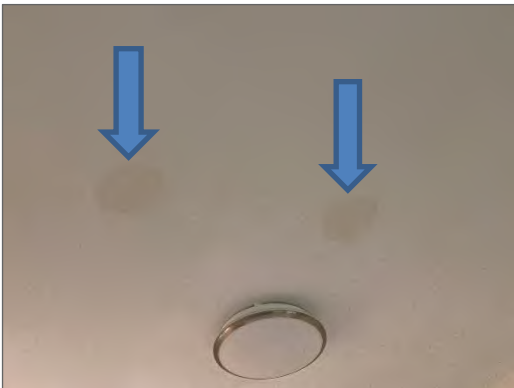
Photo 54 - Water staining on drywall ceiling in Bedroom.

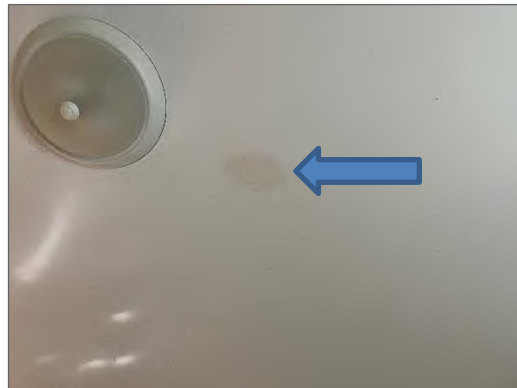
Photo 55 - Water staining on drywall ceiling in Living Area.

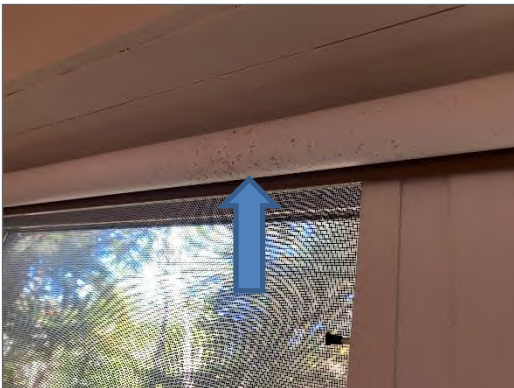
Photo 56 - Black spotting on curtain in bedroom.

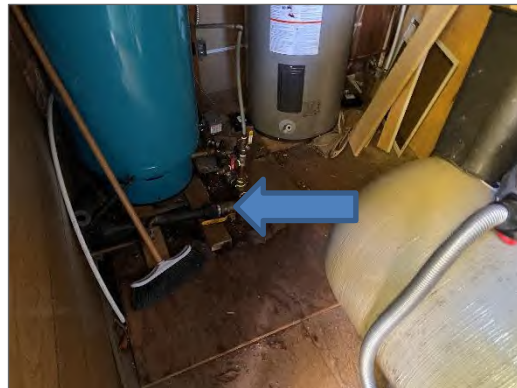
Photo 57 - Water damage under tank, floor has rotted through.

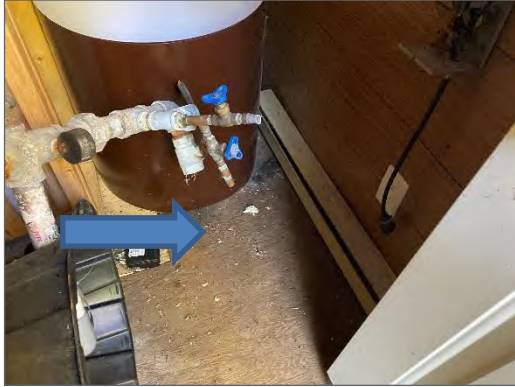
Photo 58 - Rodent droppings in Pump Room.

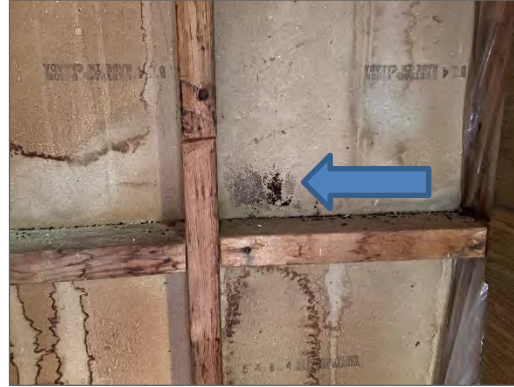
Photo 59 - Water staining and mould growth on drywall wall in Pump Room (TL-05).

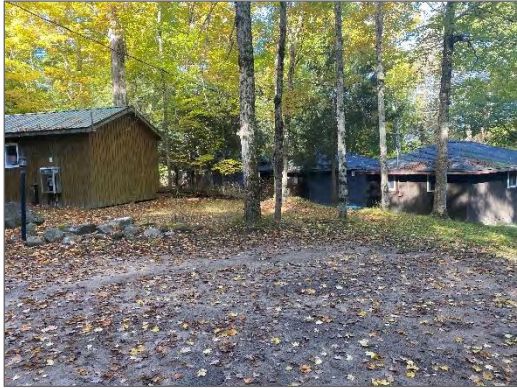
Relative Humidity	44.9 %RH	
Sample Type/Location	Sample No.	
Mould Air Sample	ST-06	
Mould Air Sample	ST-11

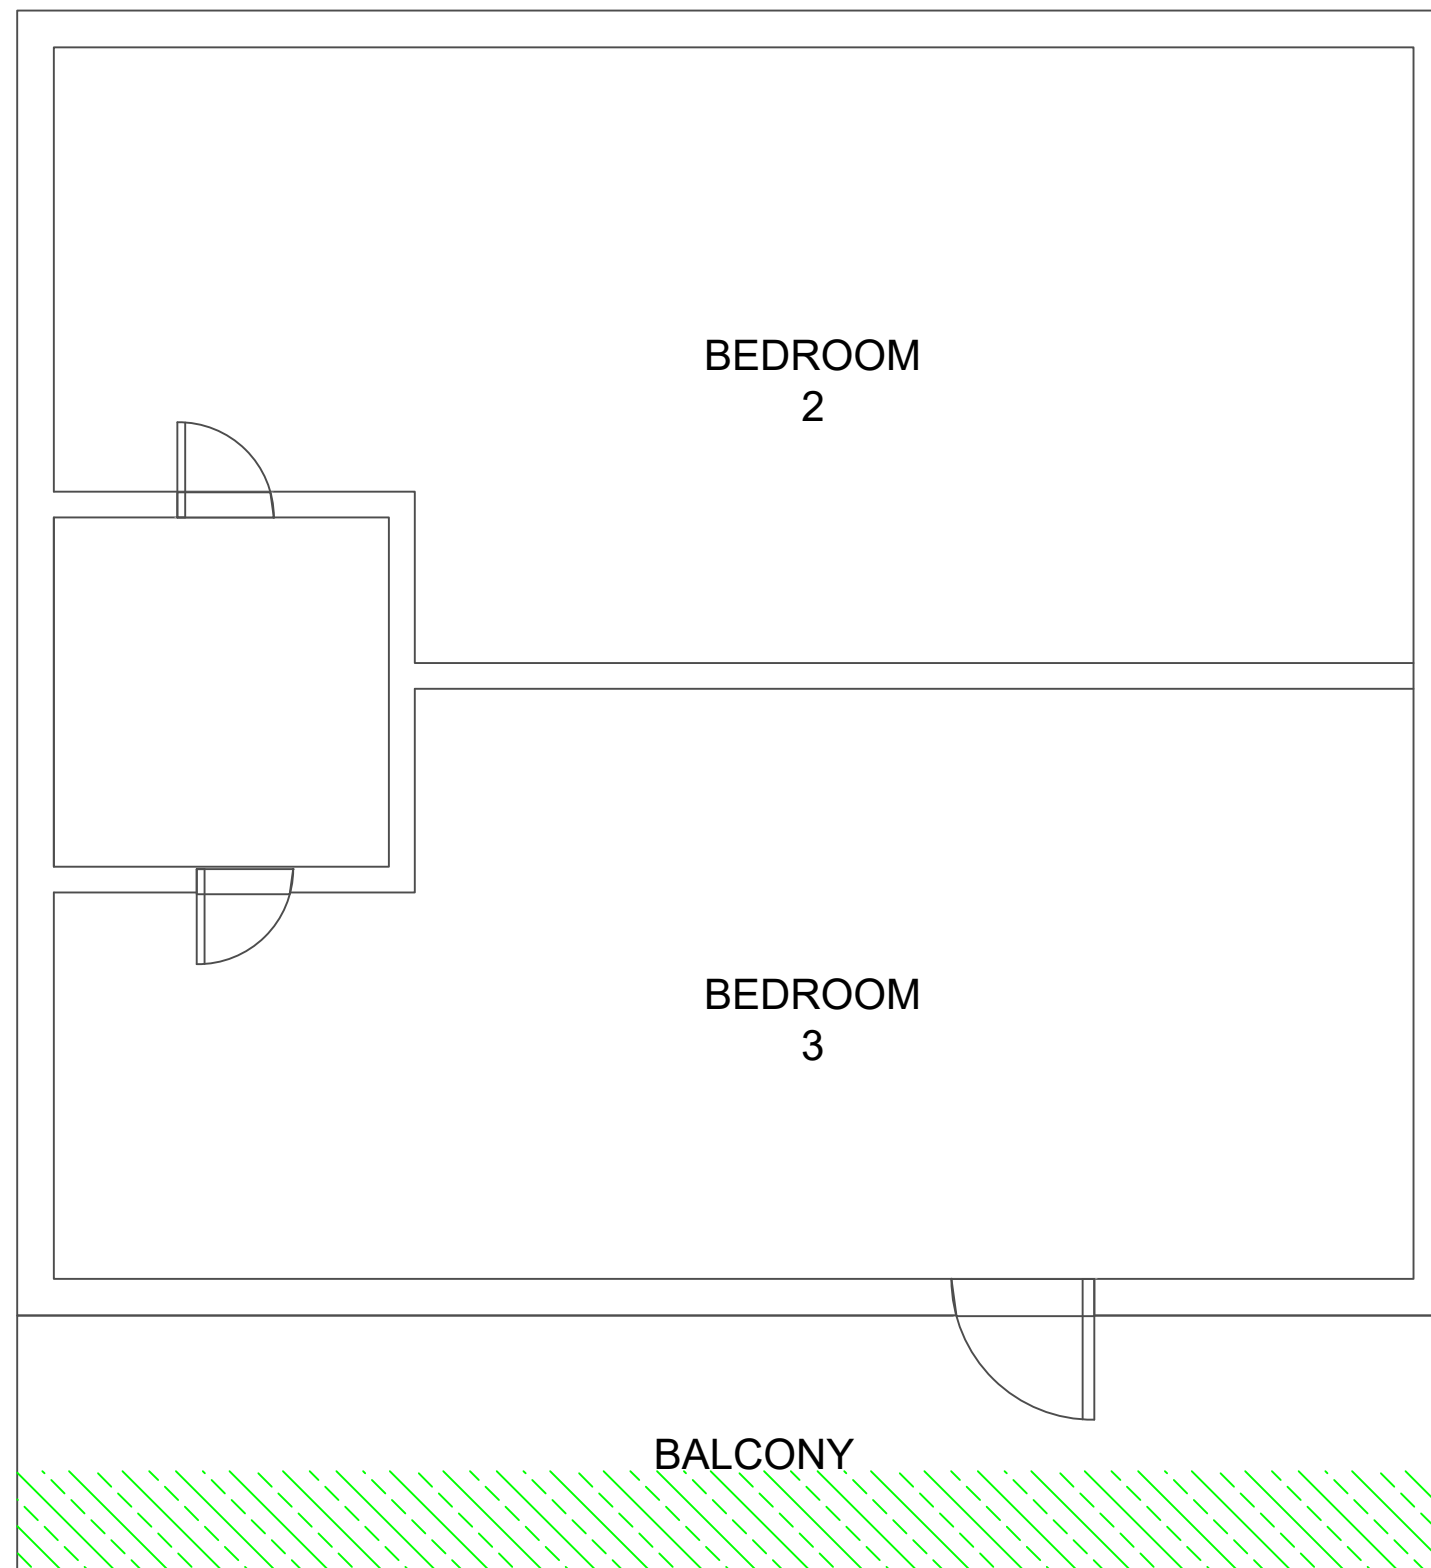
DATE: OCT 2022 FIGURE NUMBER: 3 OF 22

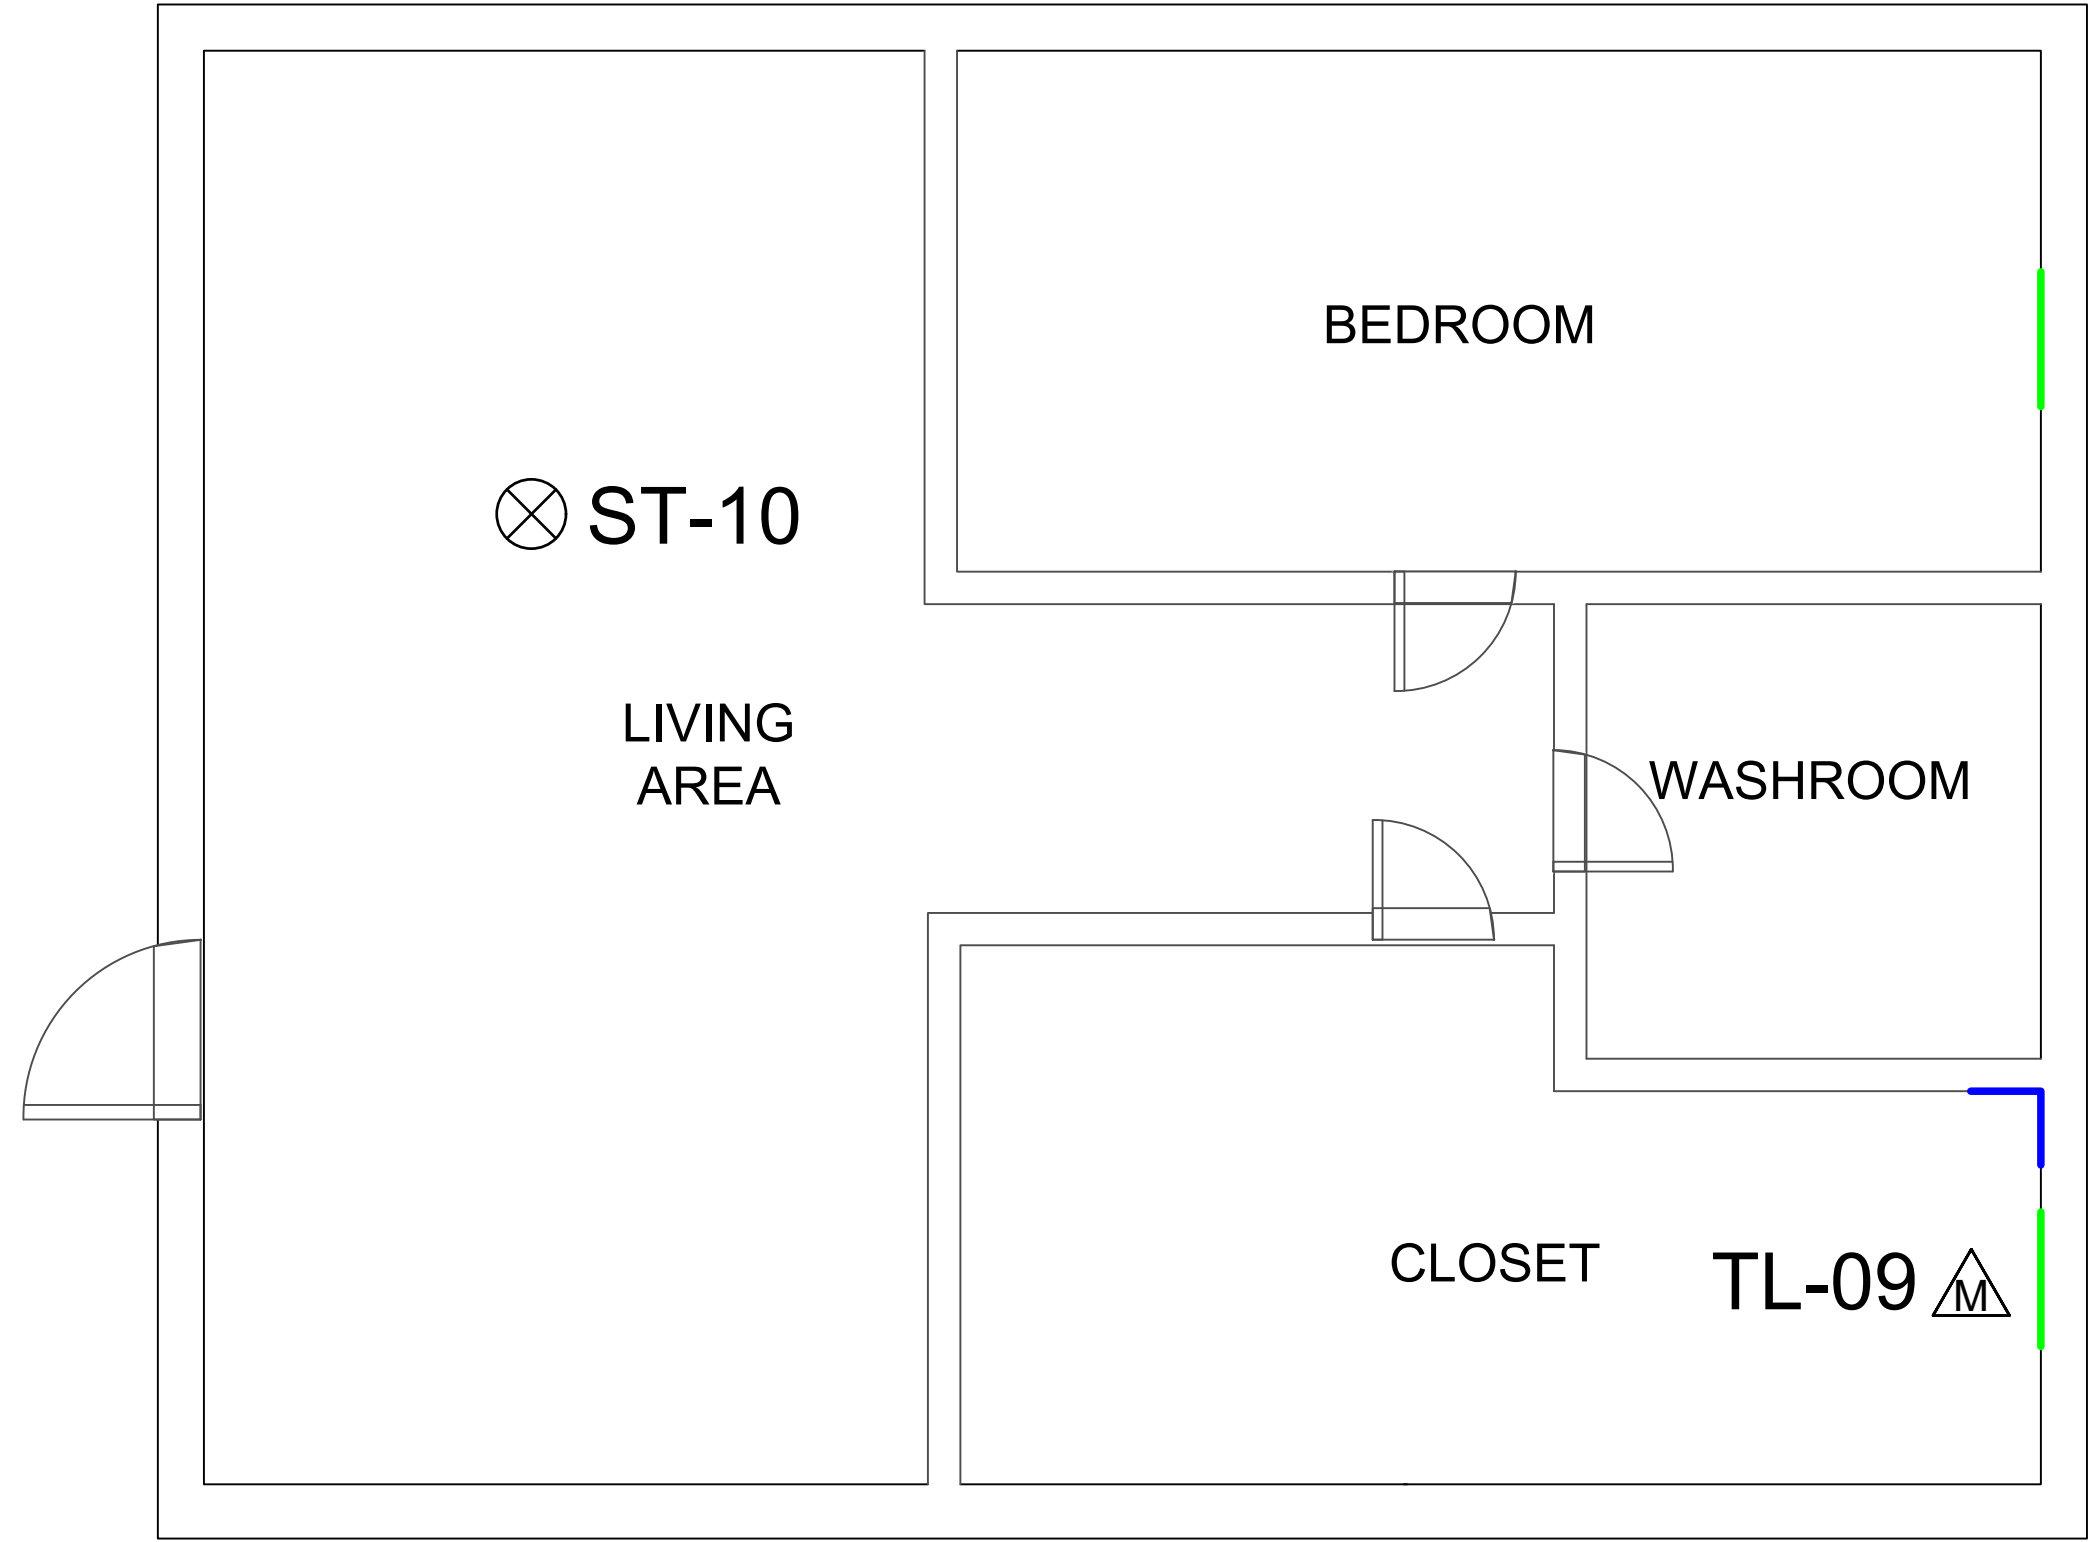
- LEGEND**
- ⊗ SPORE TRAP MOULD AIR SAMPLE
 - ▲ TAPE LIFT SAMPLE
 - ⊙ ASBESTOS BULK SAMPLE
 - ✕ WATER STAINED CEILING TILE
 - MOULD GROWTH ON WALL
 - WET WALL
 - WATER DAMAGED MATERIALS ON WALL
 - ▨ WATER STAINED/DAMAGED FLOOR
 - ▩ WATER STAINED CEILING
 - ▨ ORGANIC GROWTH
 - NAR NO ACCESS TO AREA

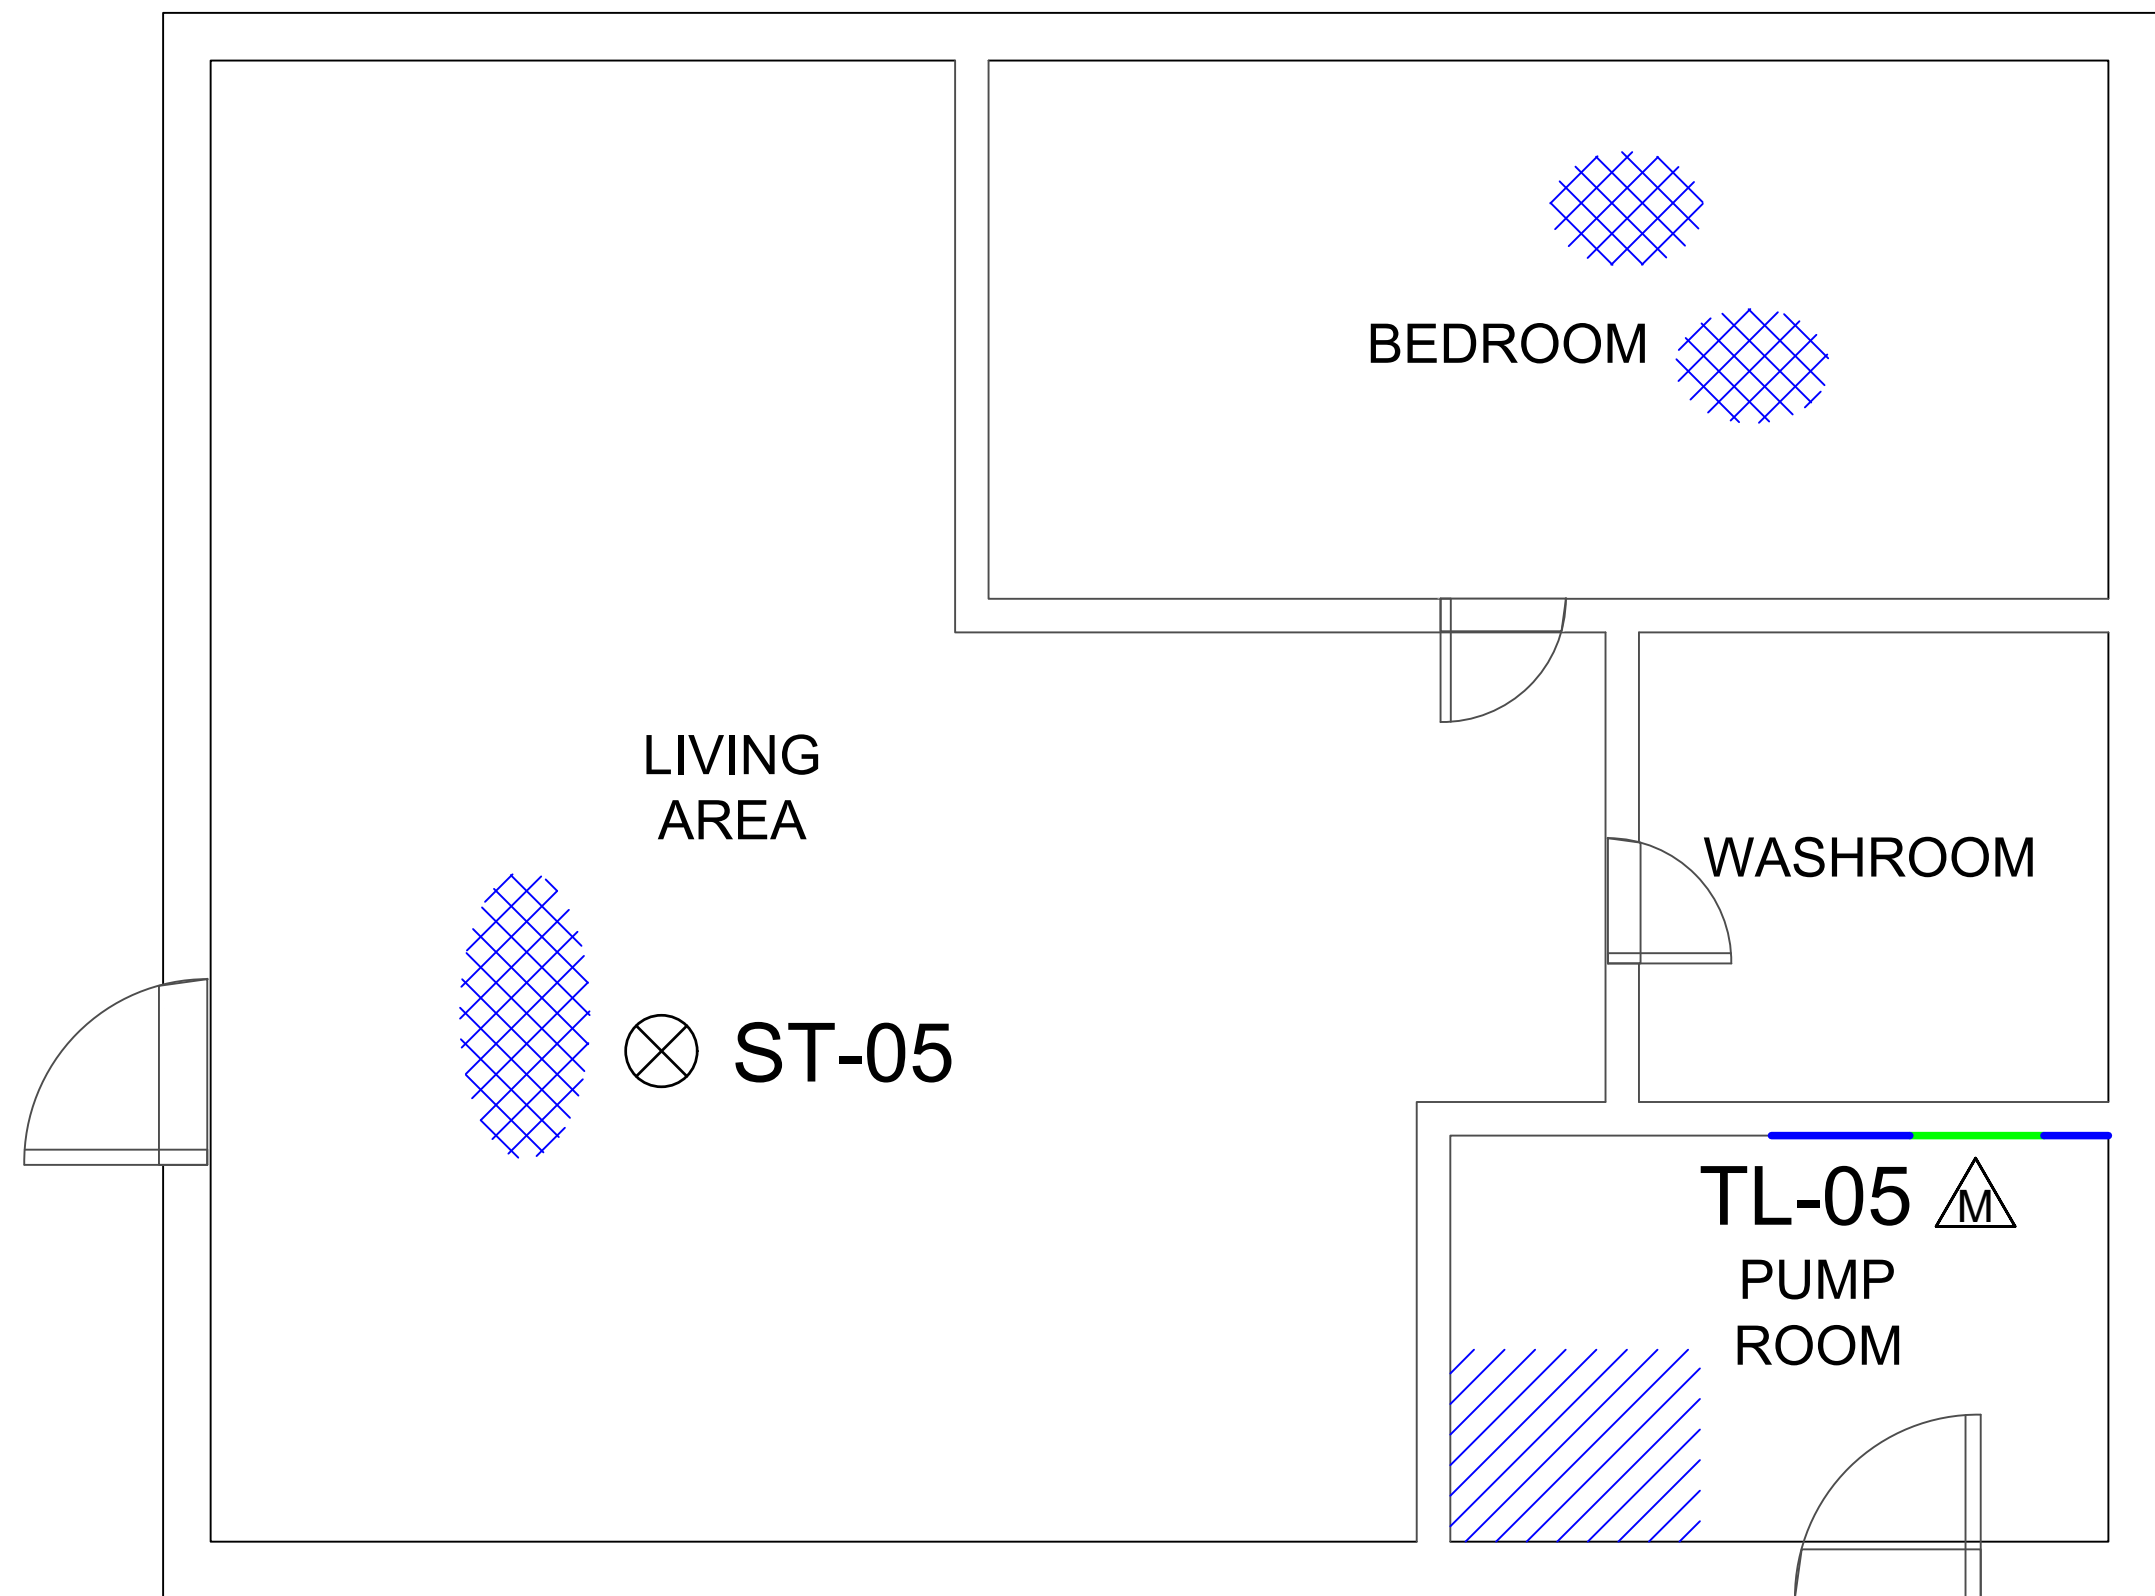
- LEGEND**
- ⊗ SPORE TRAP MOULD AIR SAMPLE
 - ▲ TAPE LIFT SAMPLE
 - ⊙ ASBESTOS BULK SAMPLE
 - ✕ WATER STAINED CEILING TILE
 - MOULD GROWTH ON WALL
 - WET WALL
 - WATER DAMAGED MATERIALS ON WALL
 - ▨ WATER STAINED/DAMAGED FLOOR
 - ▩ WATER STAINED CEILING
 - ▨ ORGANIC GROWTH
 - NAR NO ACCESS TO AREA
