Investigation of Mould Growth

Cabins 2-5, 7 and 8

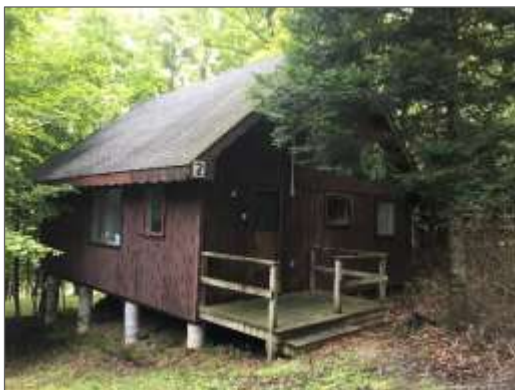
Photo 1 - Cabin 2, 1225 Grass Lake Road.

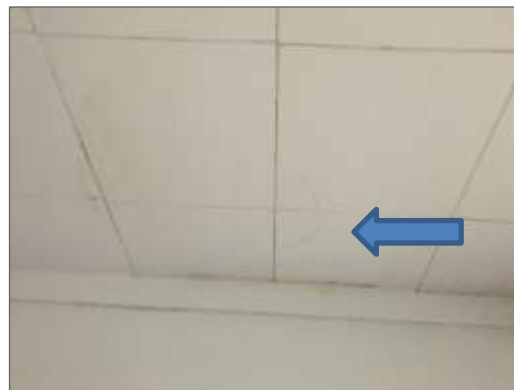
Photo 2 - Faint water staining identified on ceiling tiles.

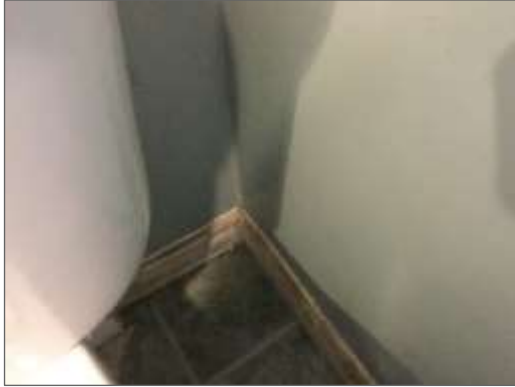
Photo 3 - Previous water damage identified in washroom; drywall is dry.

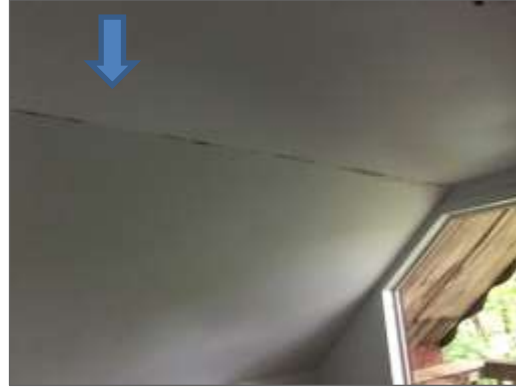
Photo 4 - Typical cracking identified in bedrooms on second floor.

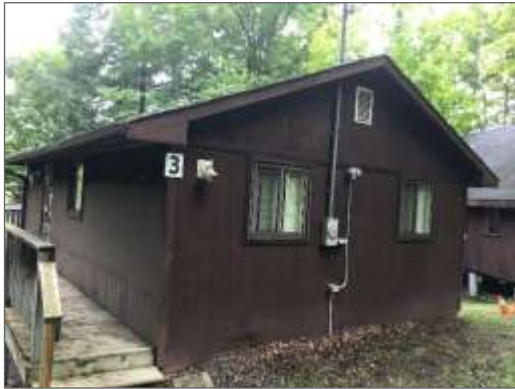
Photo 5 - Cabin 3, 1225 Grass Lake Road.

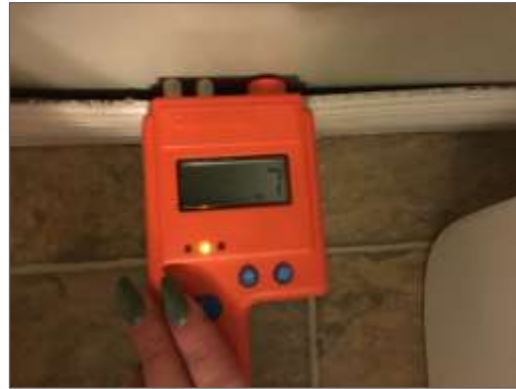
Photo 6 - Wet drywall identified behind toilet in washroom.

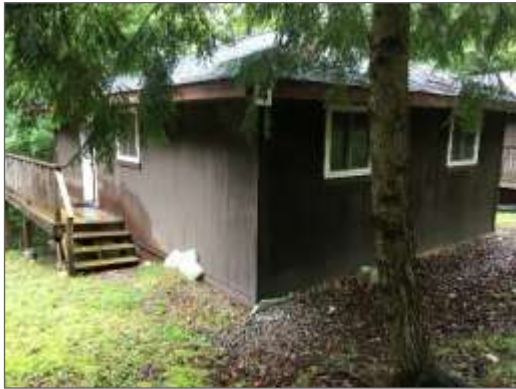
Photo 7 - Cabin 4, 1225 Grass Lake Road.

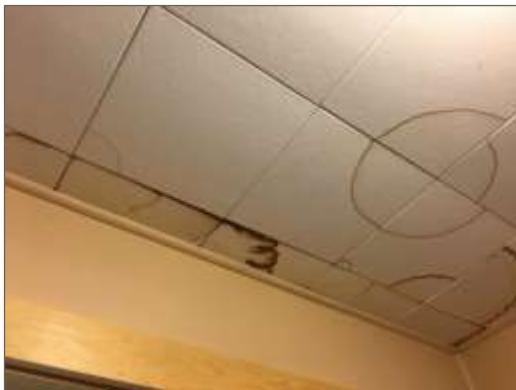
Photo 9 - Typical water staining identified on 1' x 1' tiles in various locations throughout the cabin.

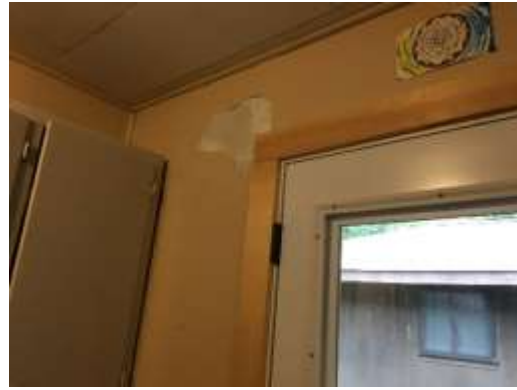
Photo 10 - Water damage to full height of drywall by kitchenette.

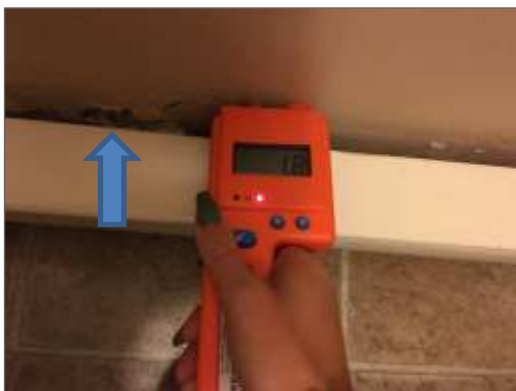
Photo 11 - Water damage identified behind radiator in washroom.

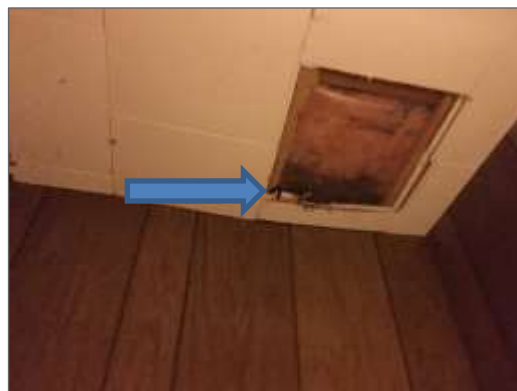
Photo 12 - Water staining identified in vapour barrier through access hatch.

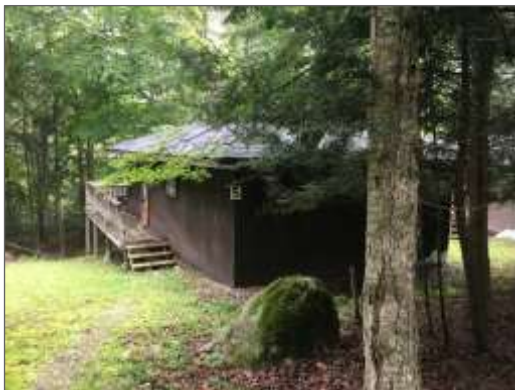
Photo 13 - Cabin 5, 1225 Grass Lake Road.

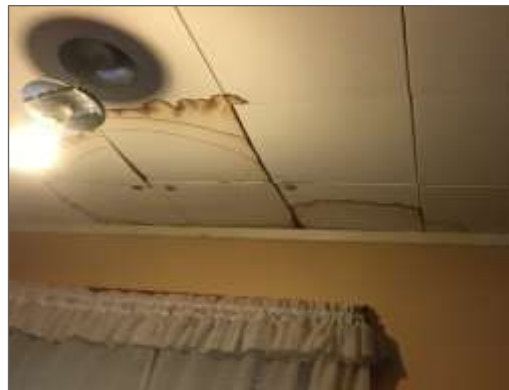
Photo 14 - Typical water staining identified on 1' x 1' tiles in various locations throughout the cabin.

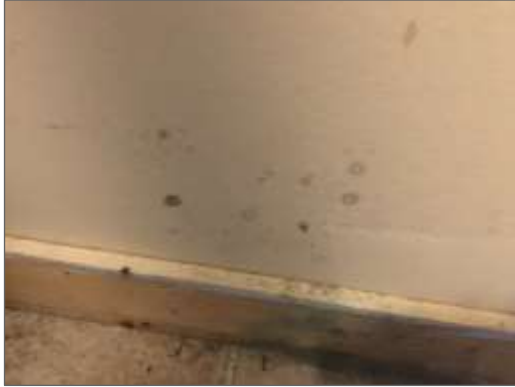
Photo 15 - Mould growth identified on drywall in living area.

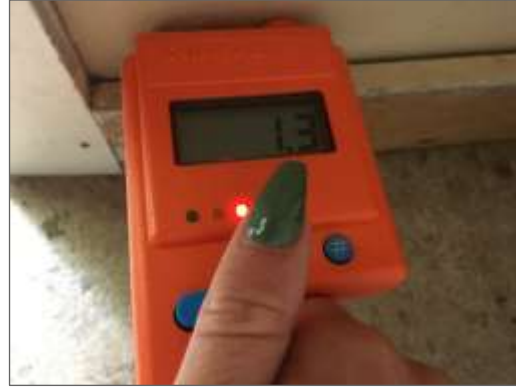
Photo 16 - Wet drywall identified in Living area.

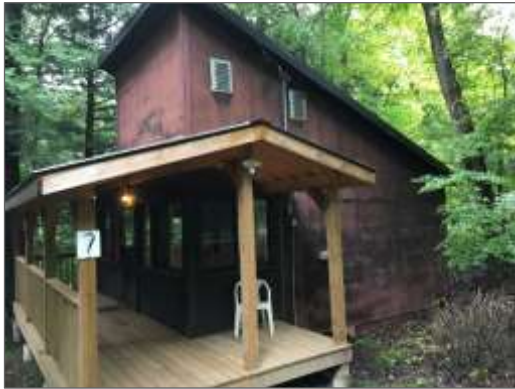
Photo 17 - Cabin 7, 1225 Grass Lake Road.

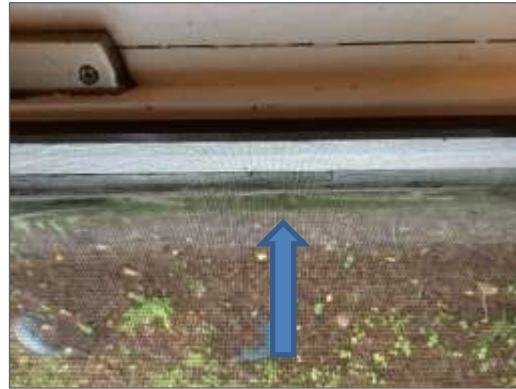
Photo 1B - Organic growth on exterior wood siding below window.

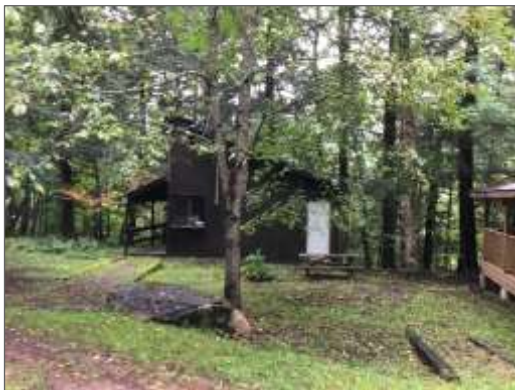
Photo 19 - Cabin 8 at 1225 Grass Lake Road.

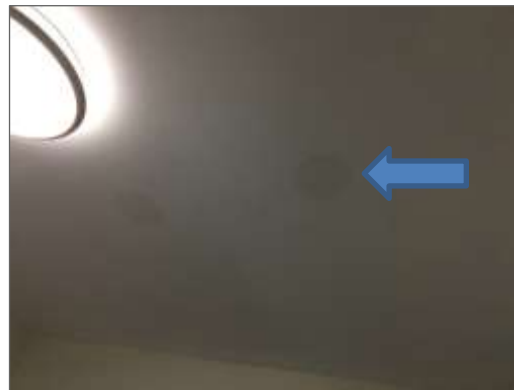
Photo 20 - Example of water staining coming through the drywall in various locations.

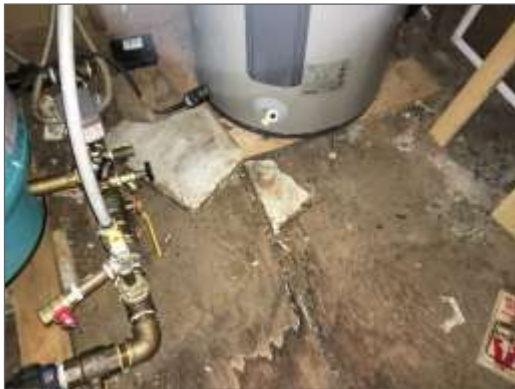
Photo 21 - Water staining on floor and mouse droppings in pump room.

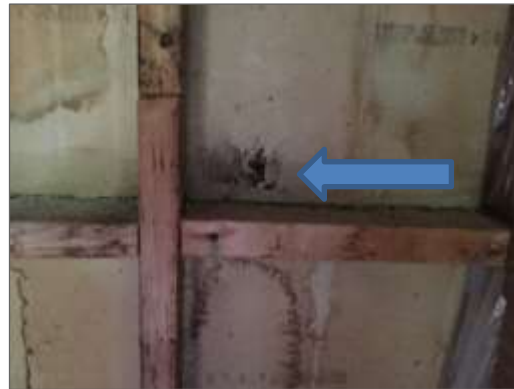
Photo 22 - Organic growth and water staining on drywall in pump room connected to washroom.

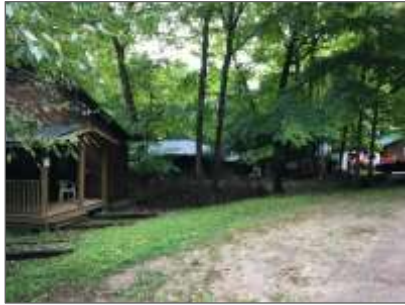
Relative Humidity	73.4 %RH	
Sample Type/Location	Sample No.	
Mould Air Sample	ST-07

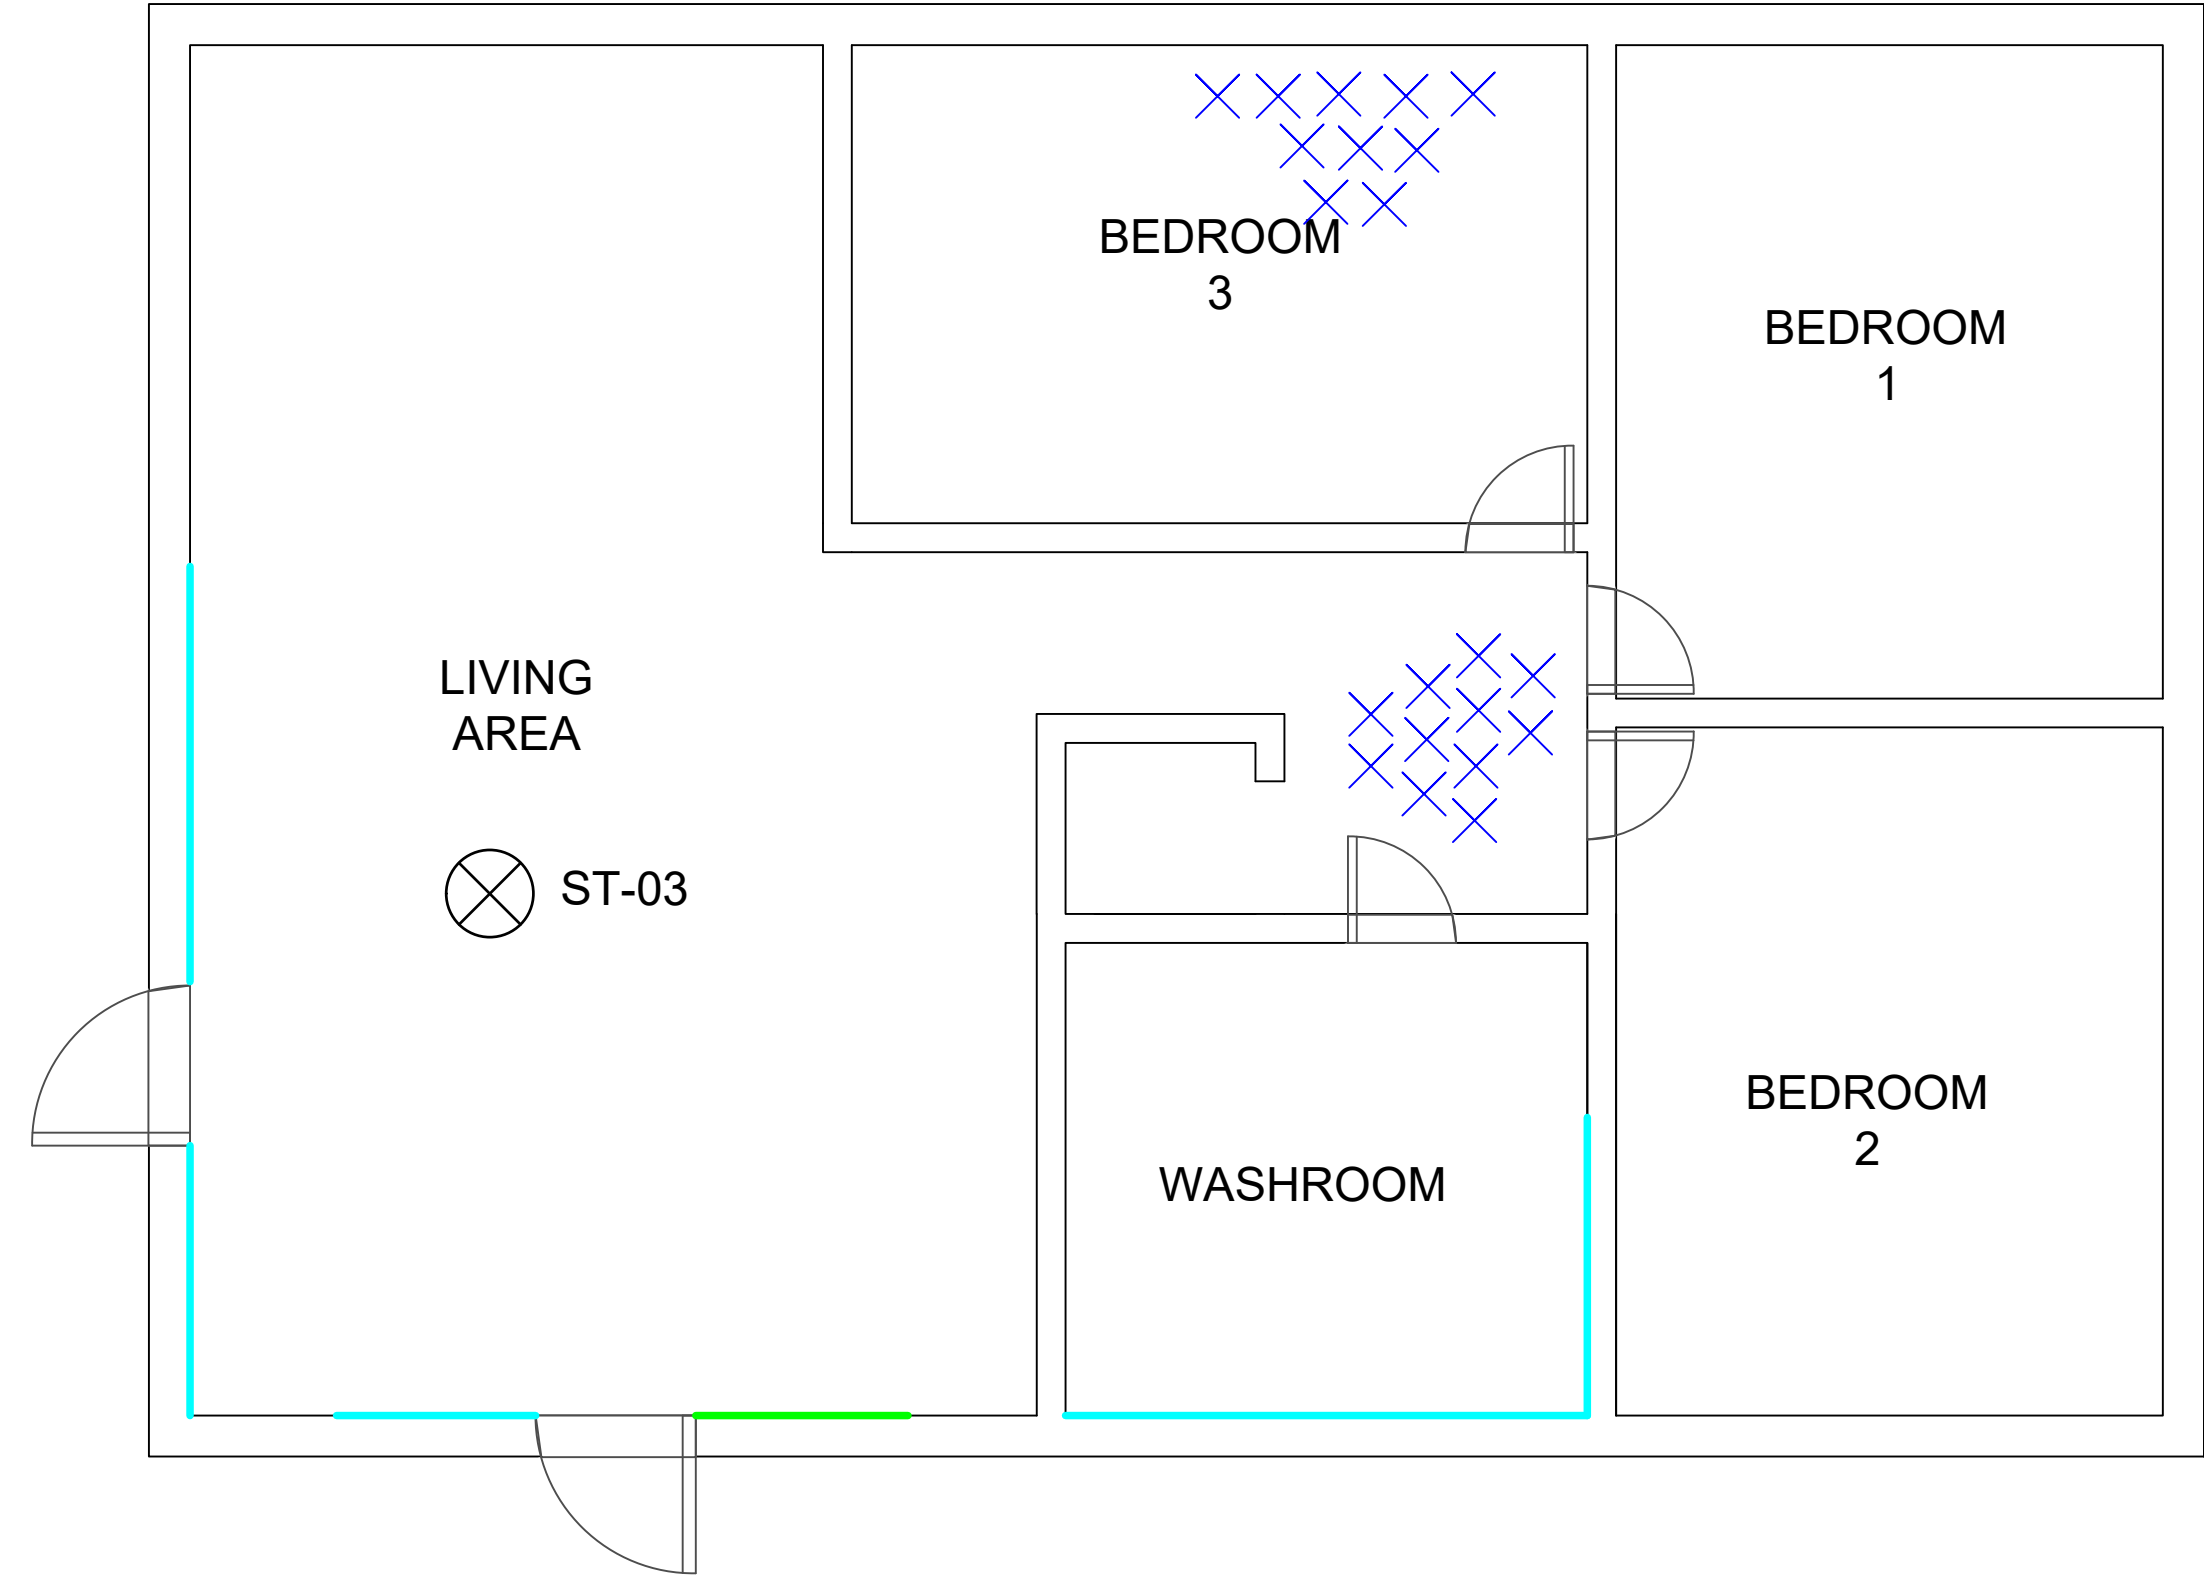
PROJECT NUMBER: 296878	SCALE: NOT TO SCALE
DRAWN BY: PINCHIN LTD.	REVIEWED BY: PINCHIN LTD.
DATE: SEPT 2021	FIGURE NUMBER: 2 OF 7

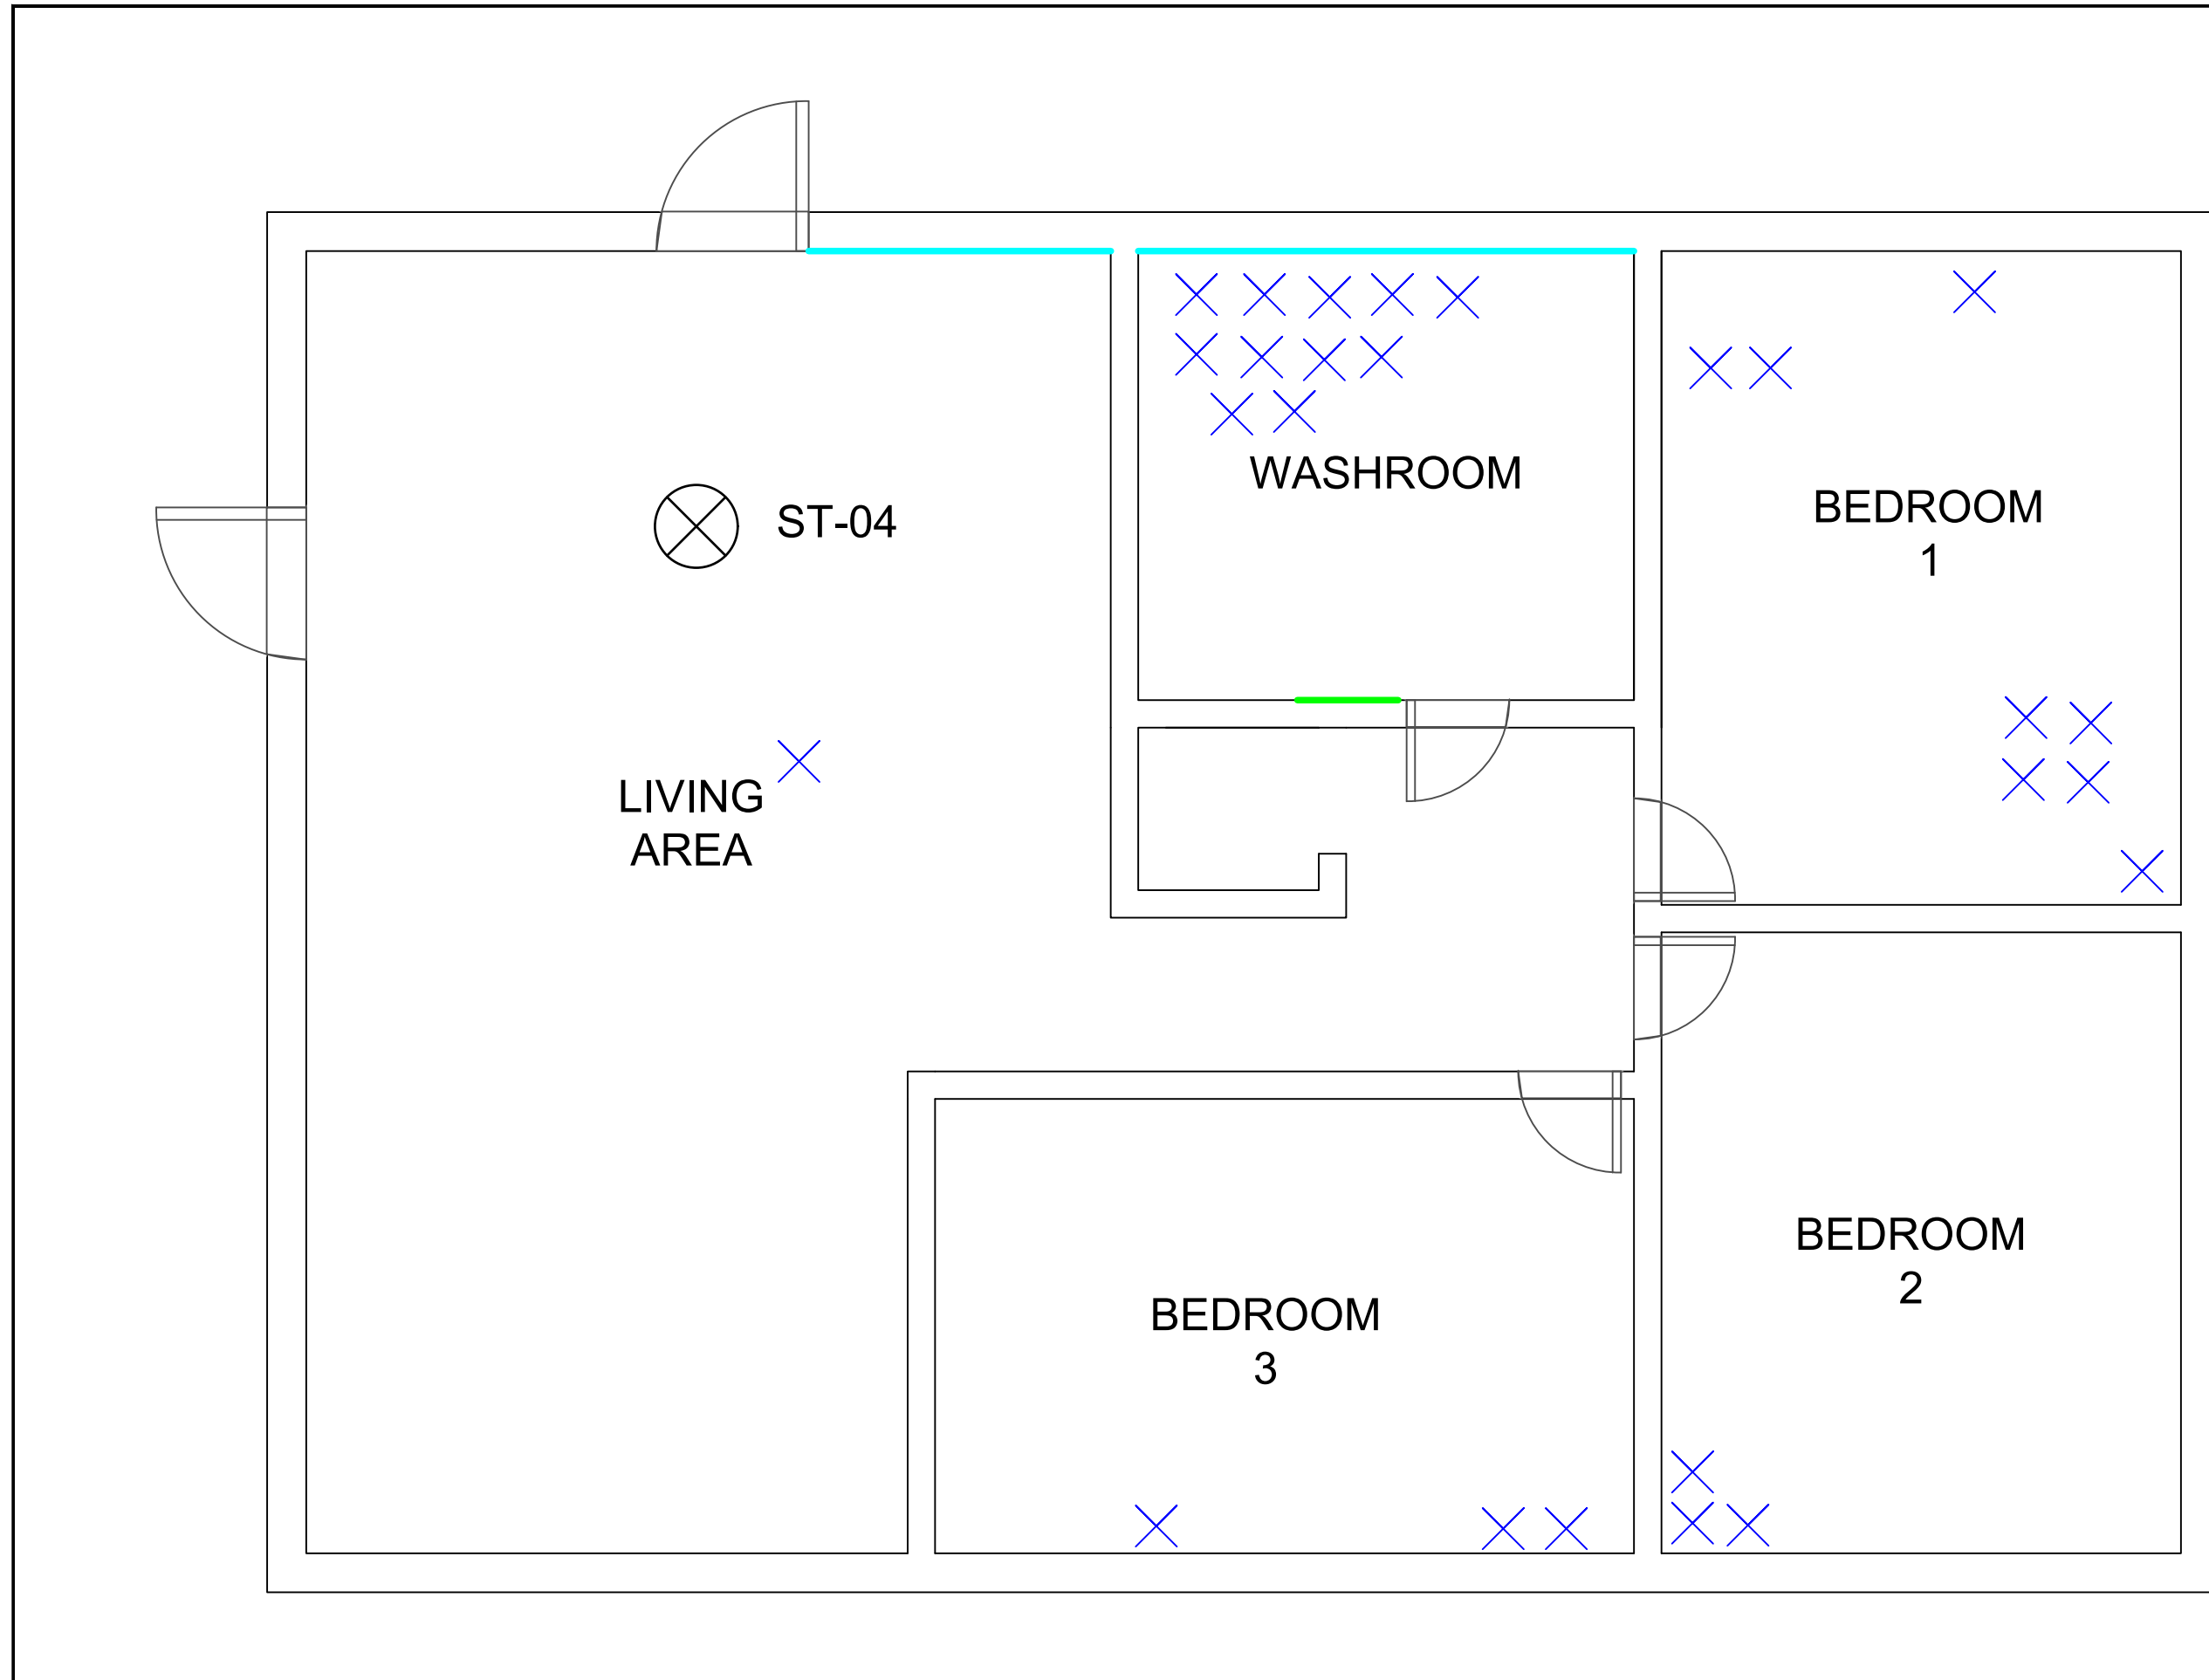
PROJECT NUMBER: 296878	SCALE: NOT TO SCALE
DRAWN BY: PINCHIN LTD.	REVIEWED BY: PINCHIN LTD.
DATE: SEPT 2021	FIGURE NUMBER: 3 OF 7

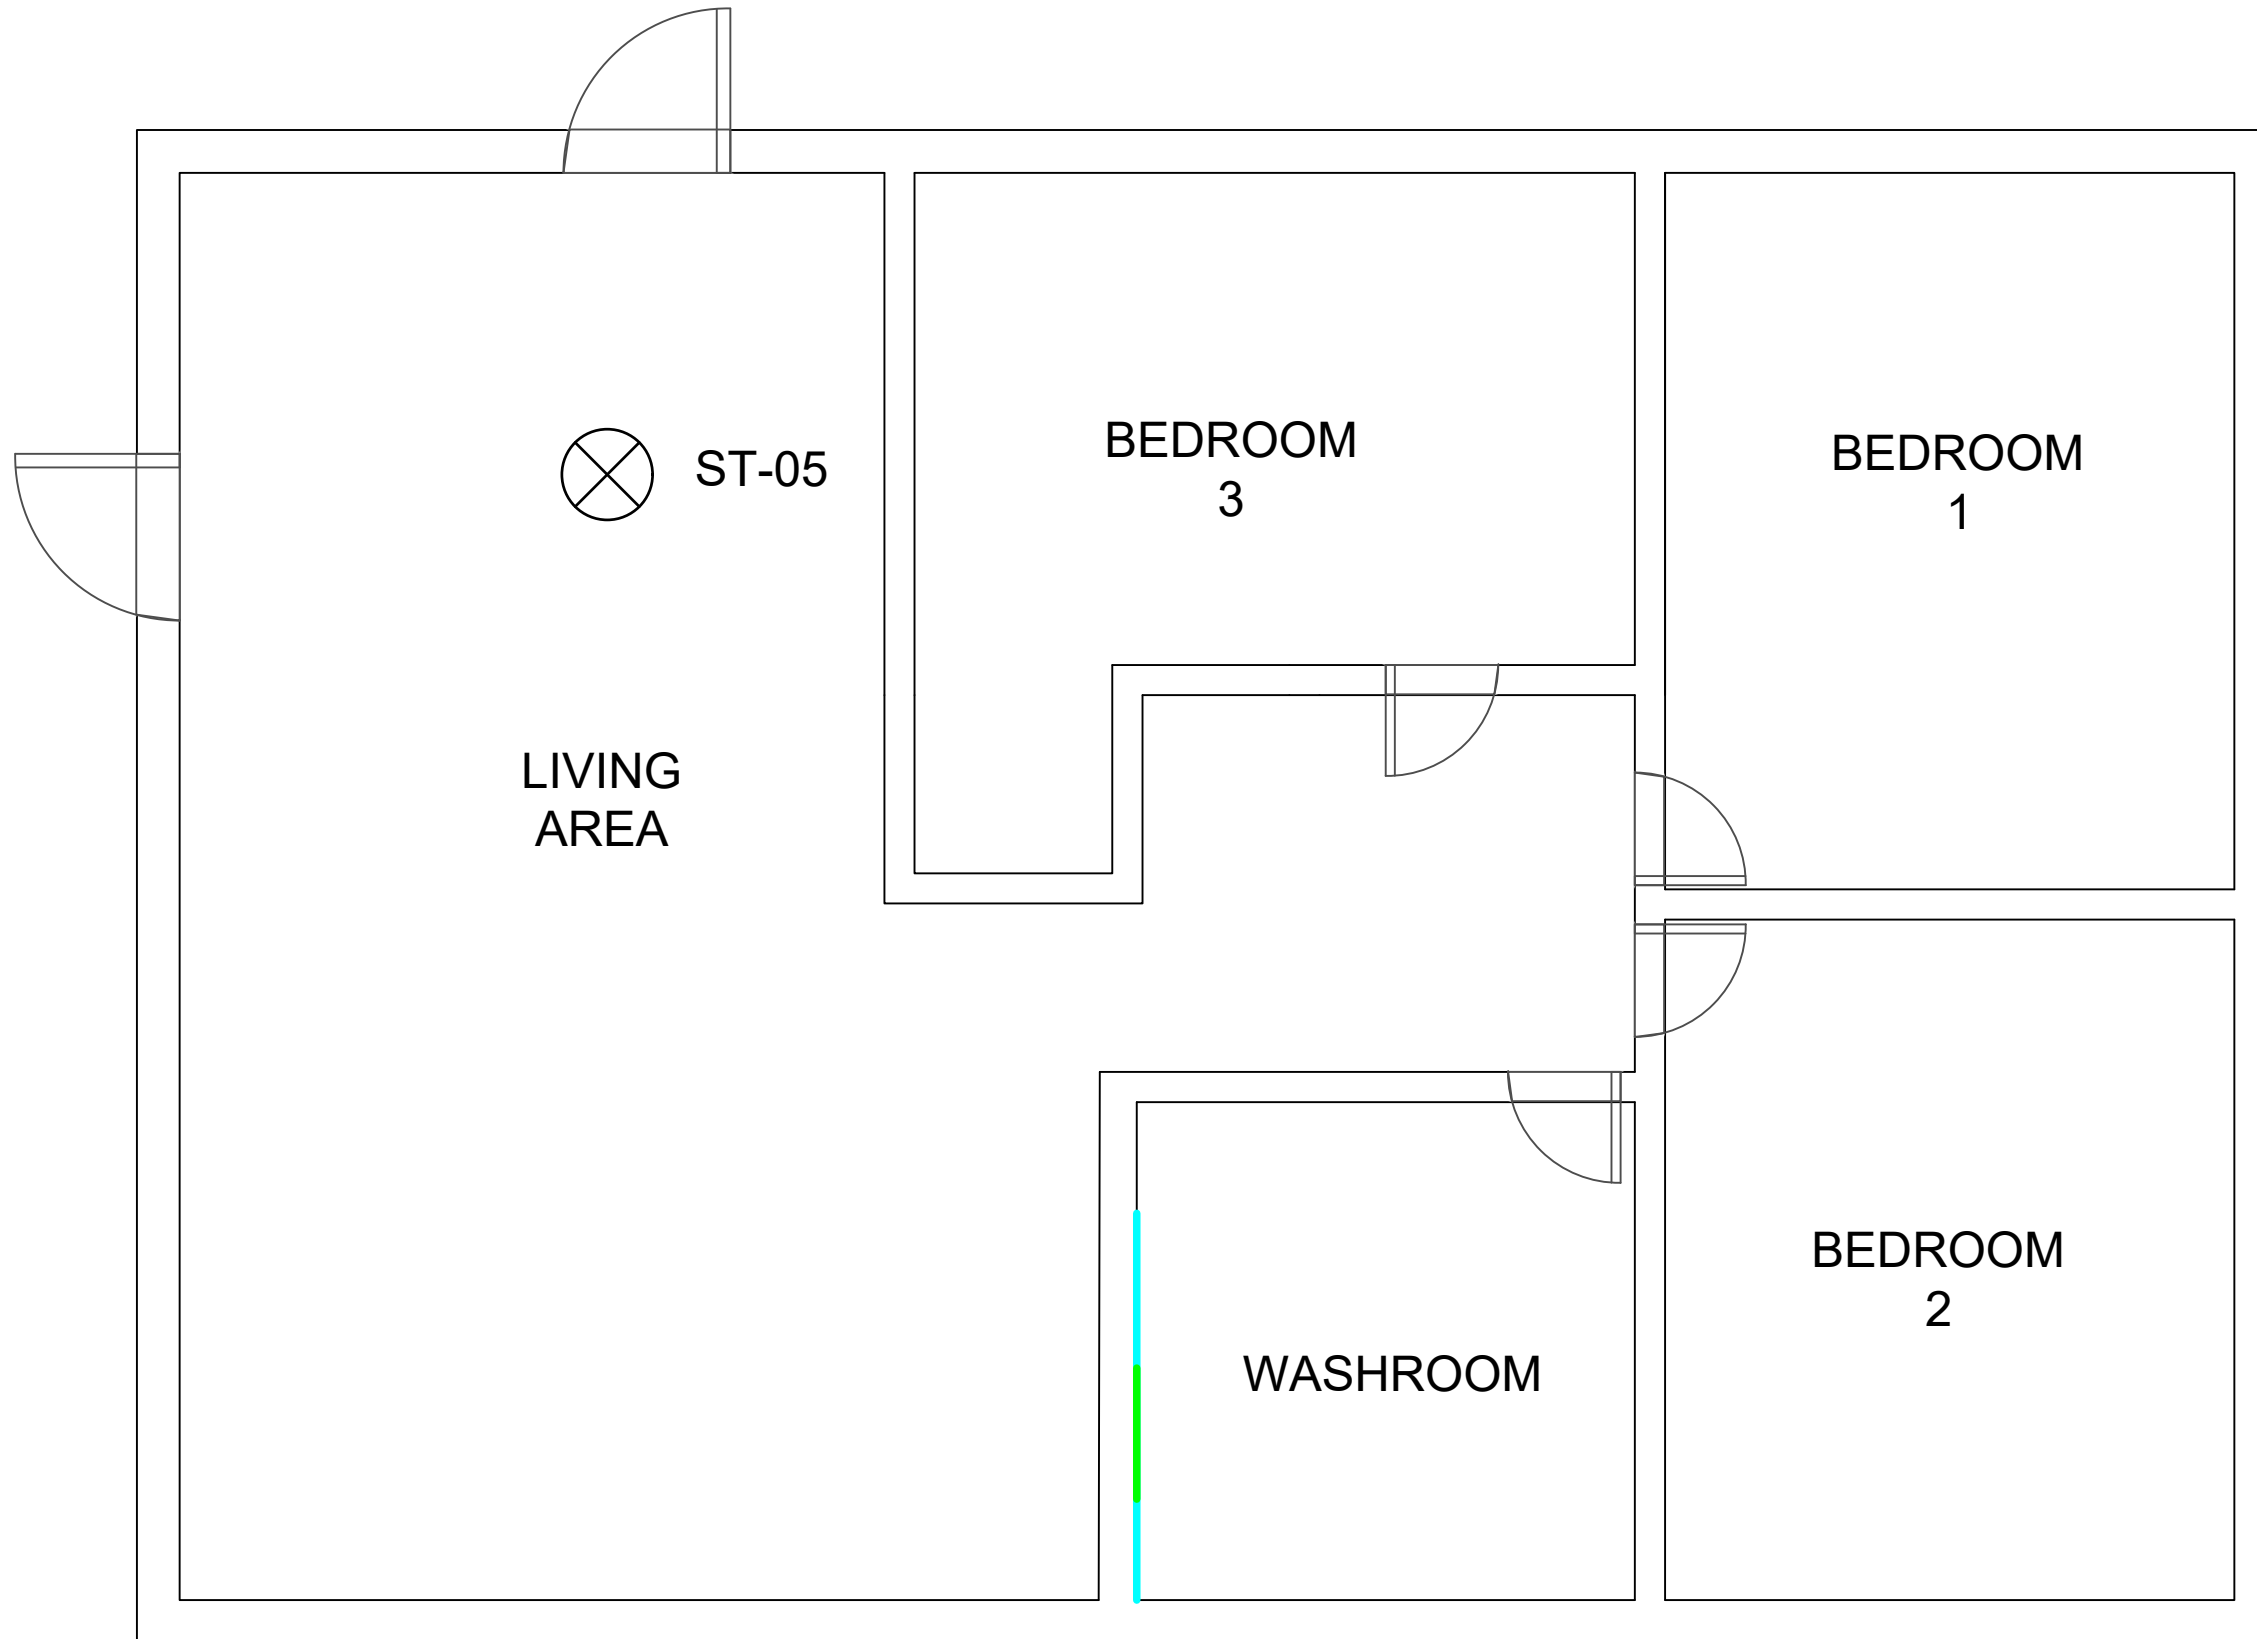
FIGURE NUMBER:
4 OF 7

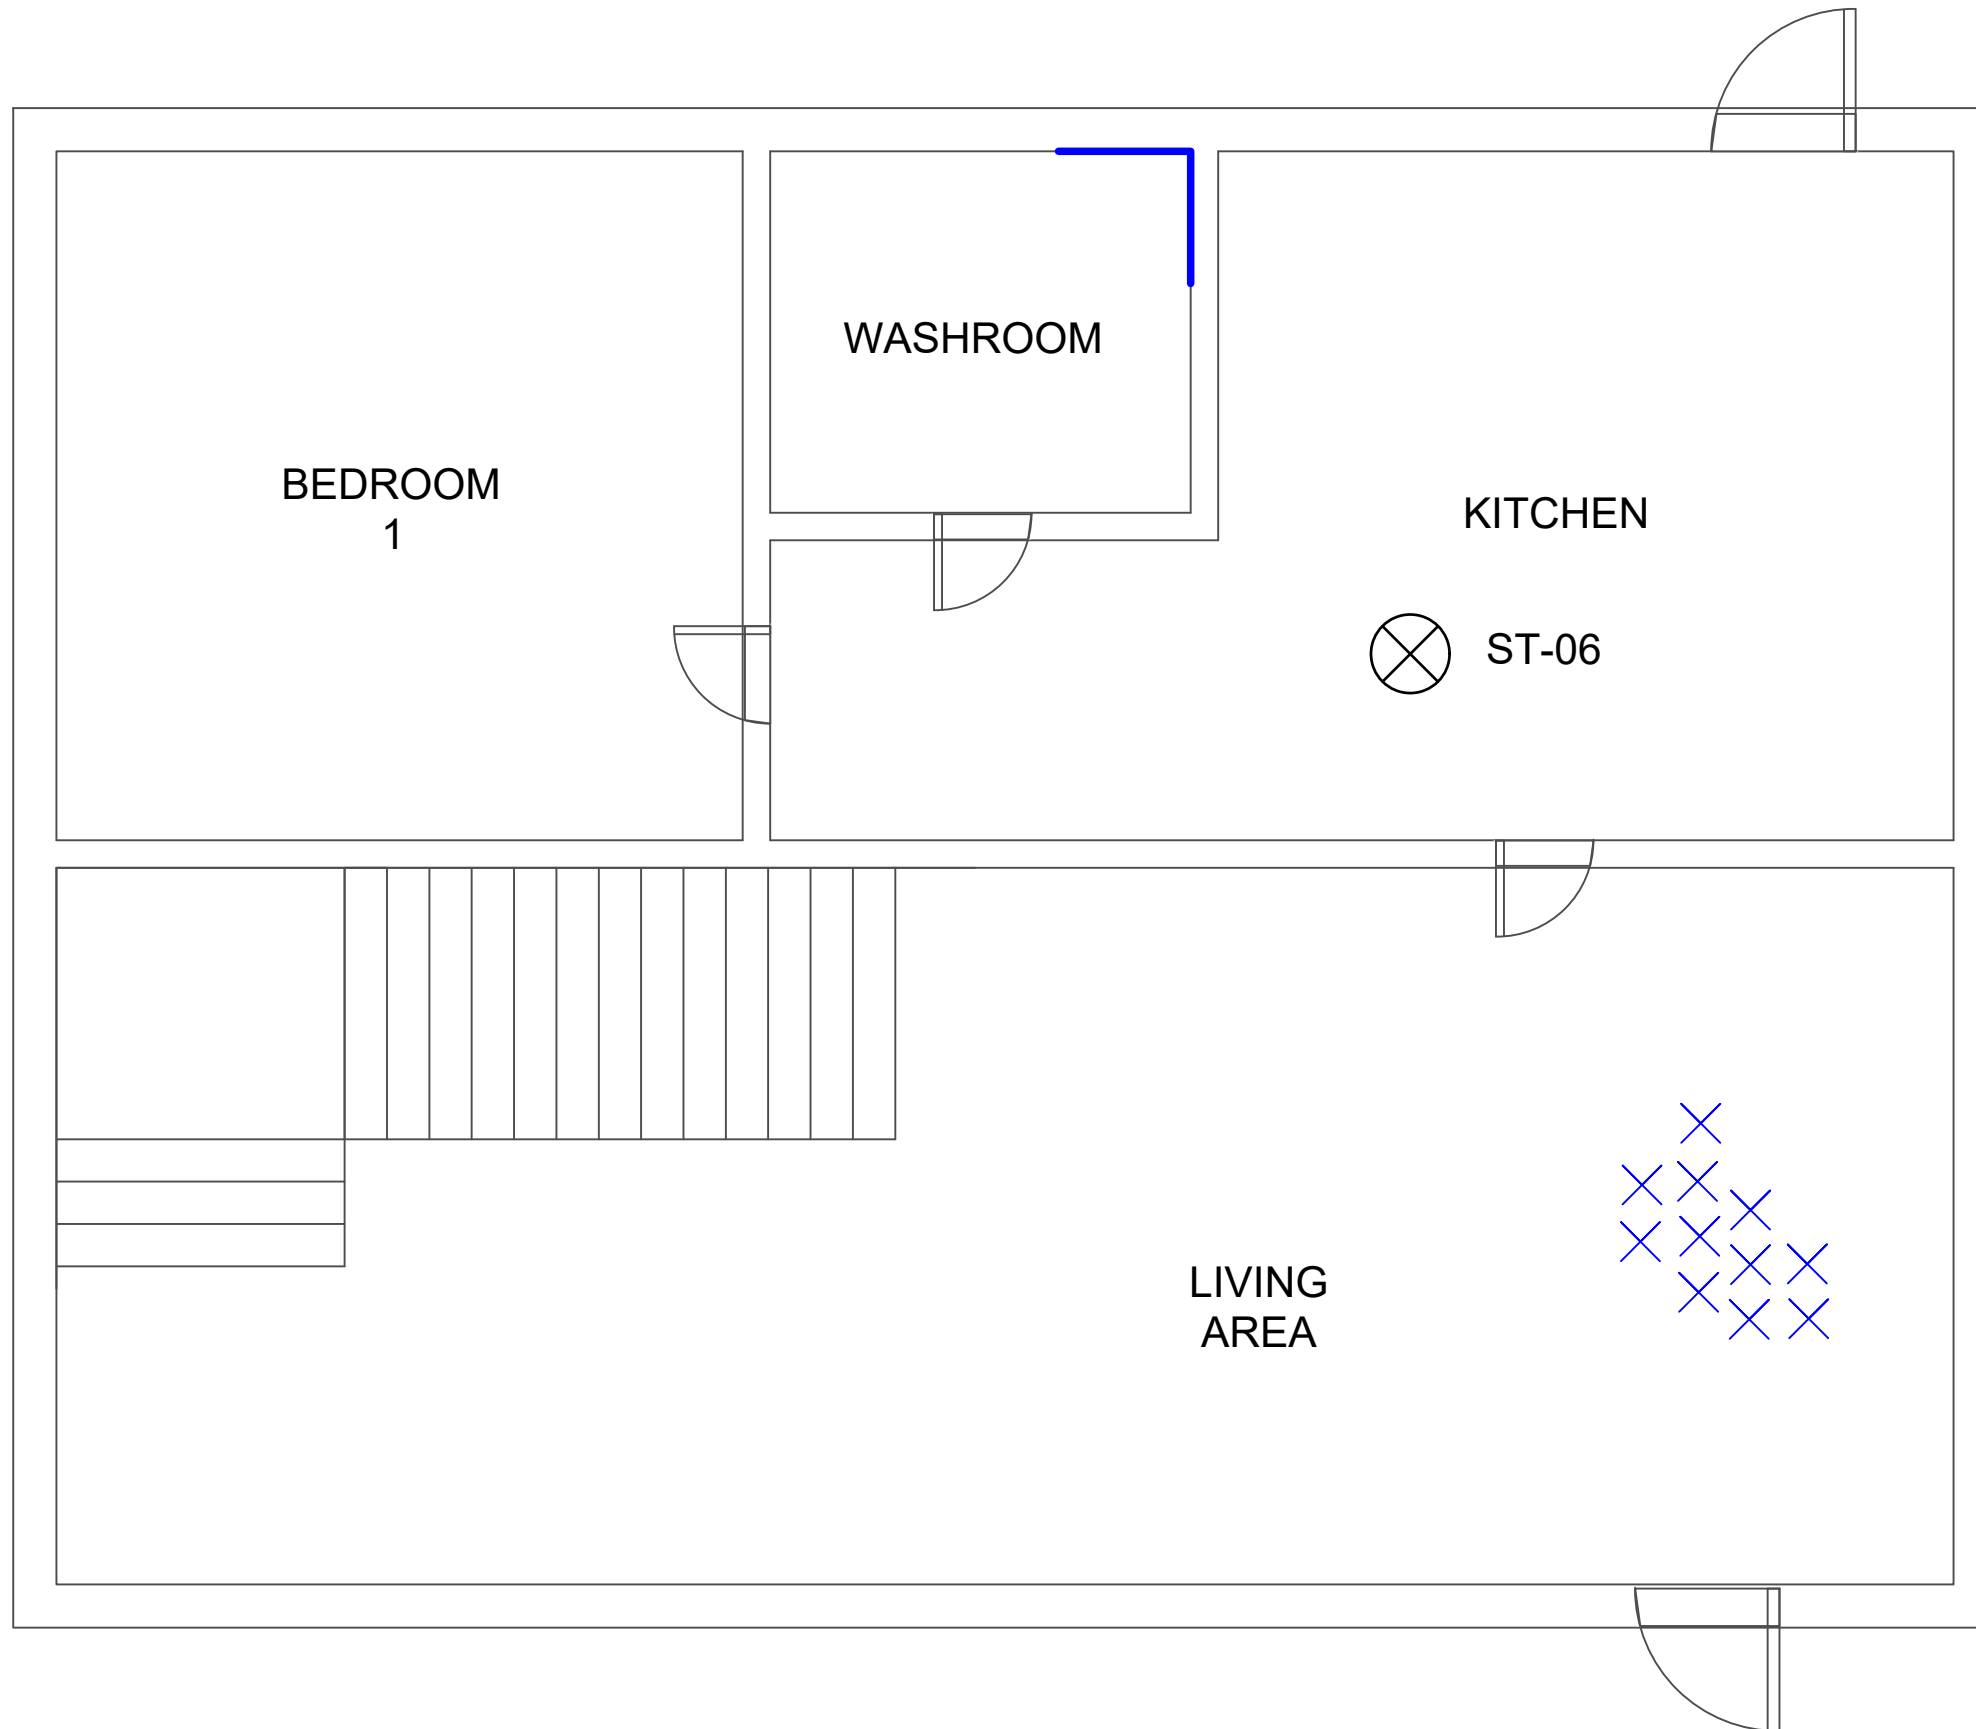
- LEGEND**
- X WATER STAINED CEILING TILE
 - MOULD GROWTH ON WALL
 - WET WALL
 - WATER DAMAGED MATERIALS ON WALL
 - ▨ WATER STAINED FLOOR
 - ▩ WATER STAINED CEILING
 - ⊗ SPORE TRAP MOULD AIR SAMPLE

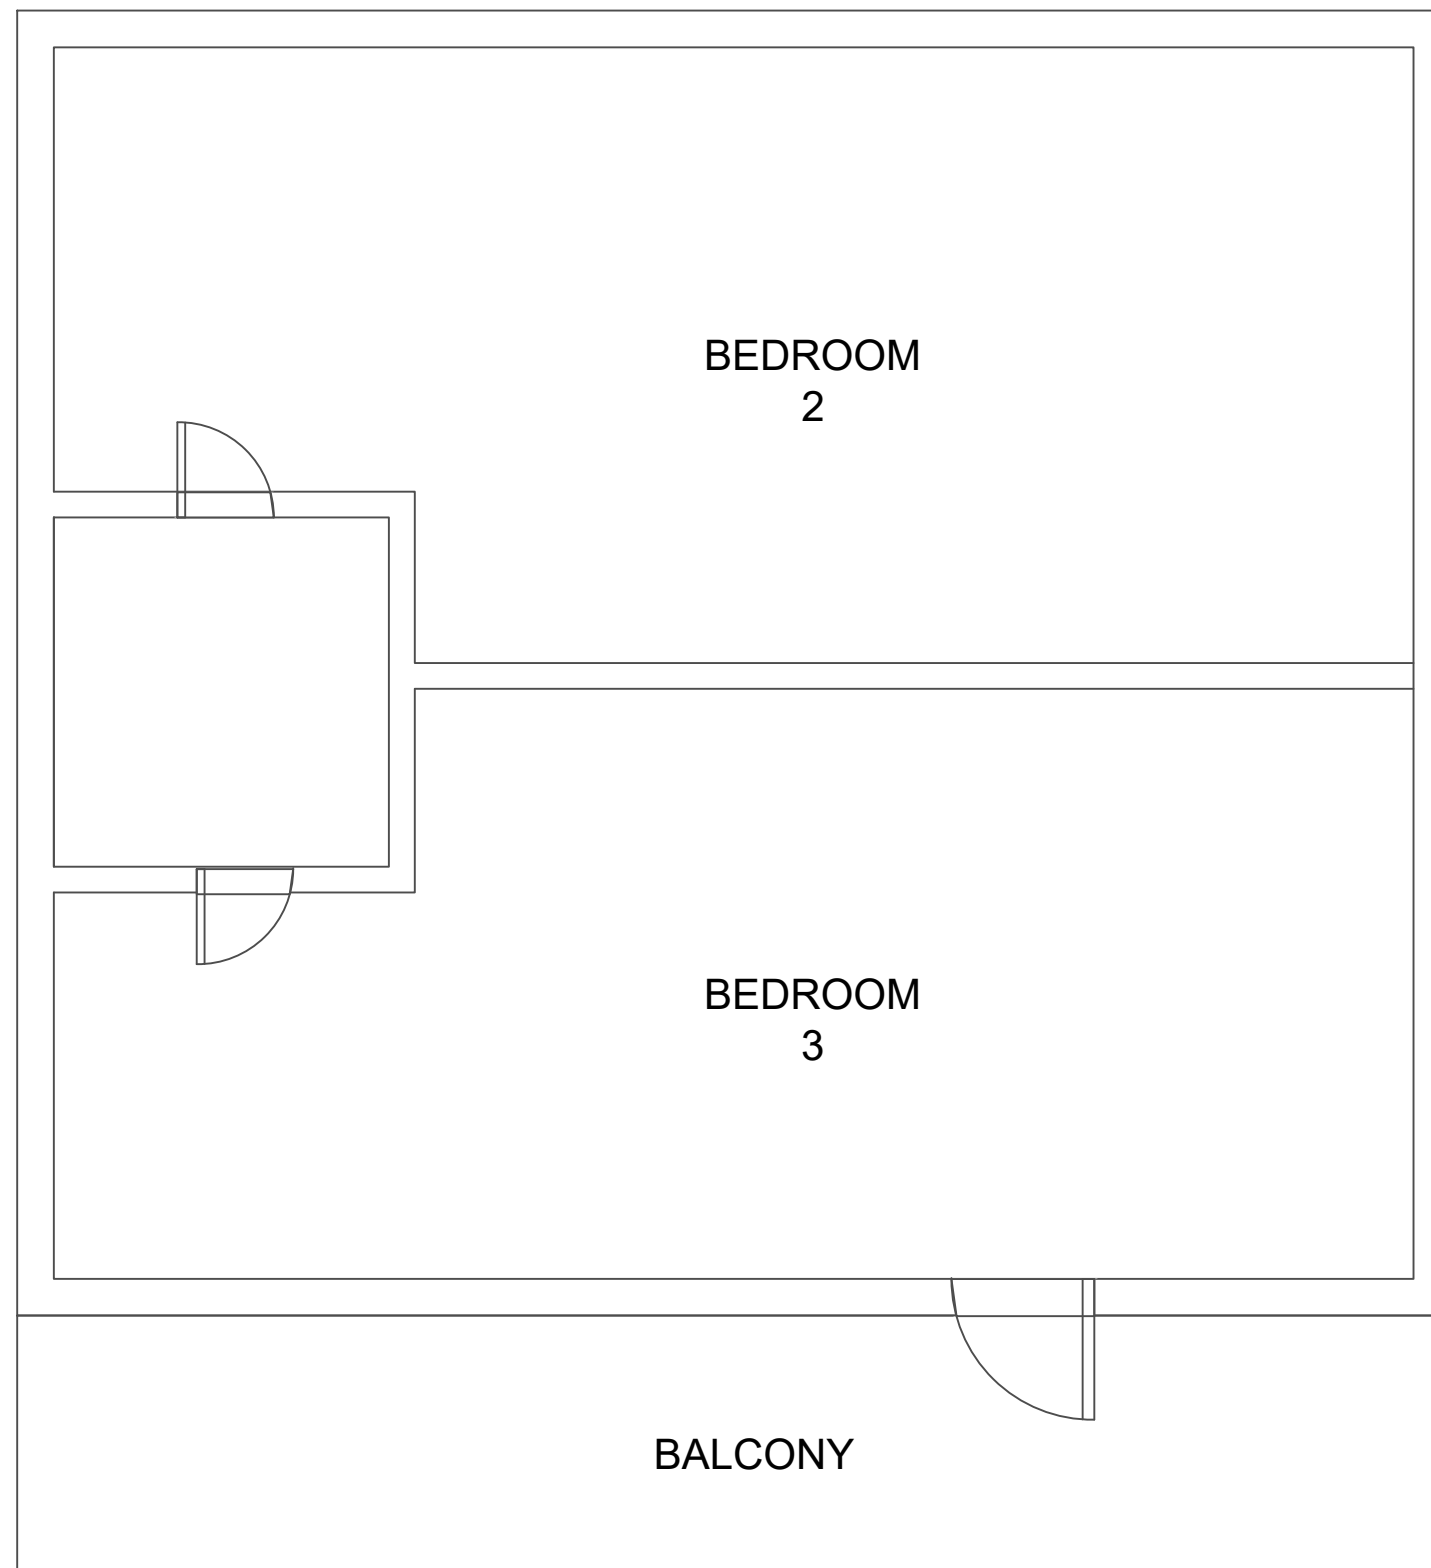
PROJECT NAME: MOULD AND WATER DAMAGE INVESTIGATION	
CLIENT NAME: FLEMING COLLEGE	
PROJECT LOCATION: CABIN 2 1225 GRASS LAKE ROAD HALIBURTON, ONTARIO	
FIGURE NAME: CABIN 2 GROUND FLOOR	
PROJECT NUMBER: 296878	SCALE: NOT TO SCALE
DRAWN BY: PINCHIN LTD.	REVIEWED BY: PINCHIN LTD.
DATE: SEPT 2021	FIGURE NUMBER: 6 OF 7
