**RE: Asbestos Abatement Inspection - THEM Project #18219**  
Sir Sandford Fleming College - 599 Brealey Drive, Peterborough, ON  
Type 2 Removal of Asbestos-Containing Drywall Joint Compound

**Asbestos Abatement Inspection Report**  
Sir Sandford Fleming College  
599 Brealey Drive, Peterborough, ON

**THEM PROJECT #18219**  
**FEBRUARY 2023**

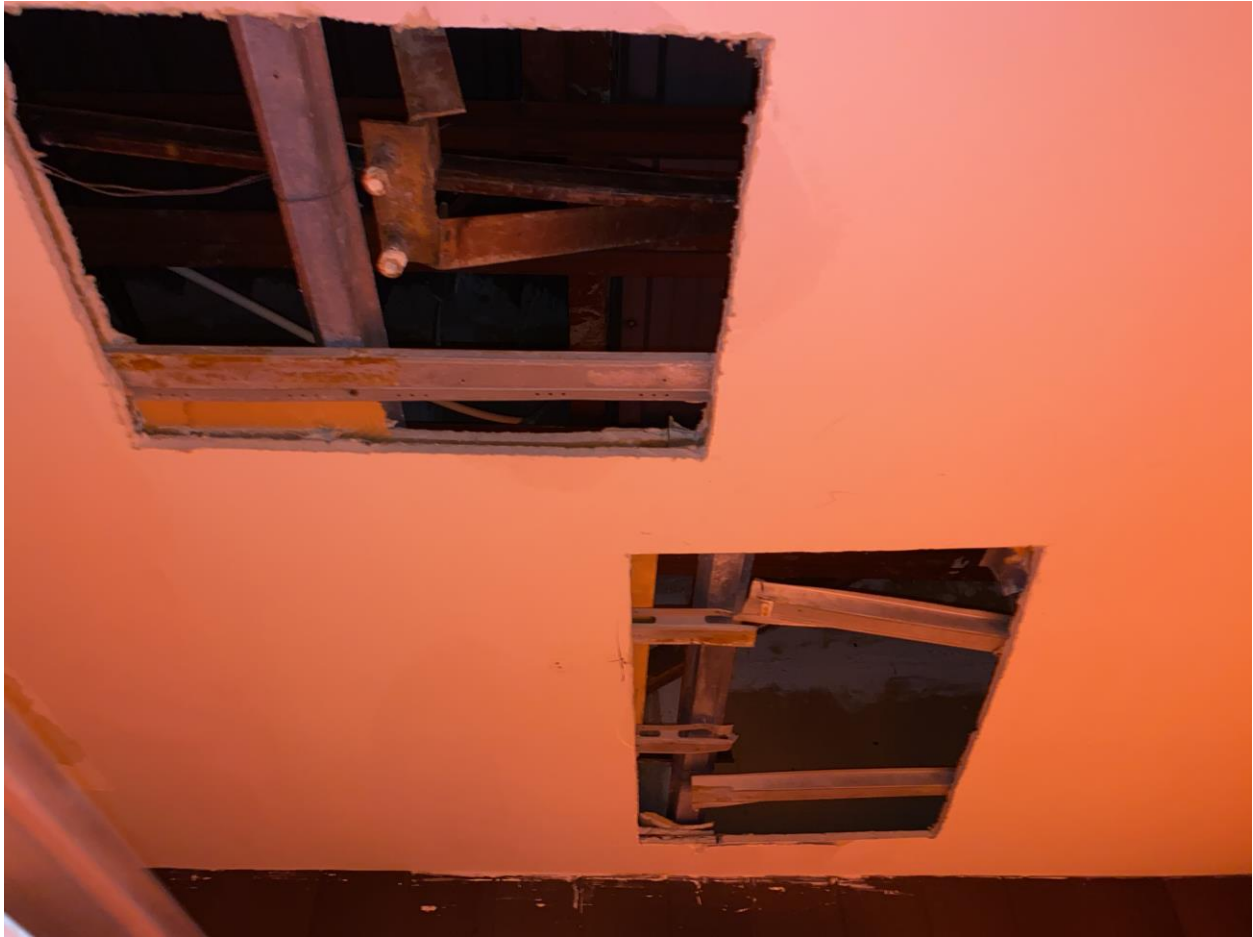
**Photograph 1:** View of the project area ceiling where approx. nine (9) ft<sup>2</sup> of asbestos-containing drywall was removed.

In addition, THEM noted that the specified asbestos-containing drywall in the ceiling had been removed. No visible dust or debris were observed at the time of the final visual inspection. The enclosure was observed to have been well maintained and in good integrity, and all waste was double bagged in yellow asbestos bags and made ready for disposal offsite.

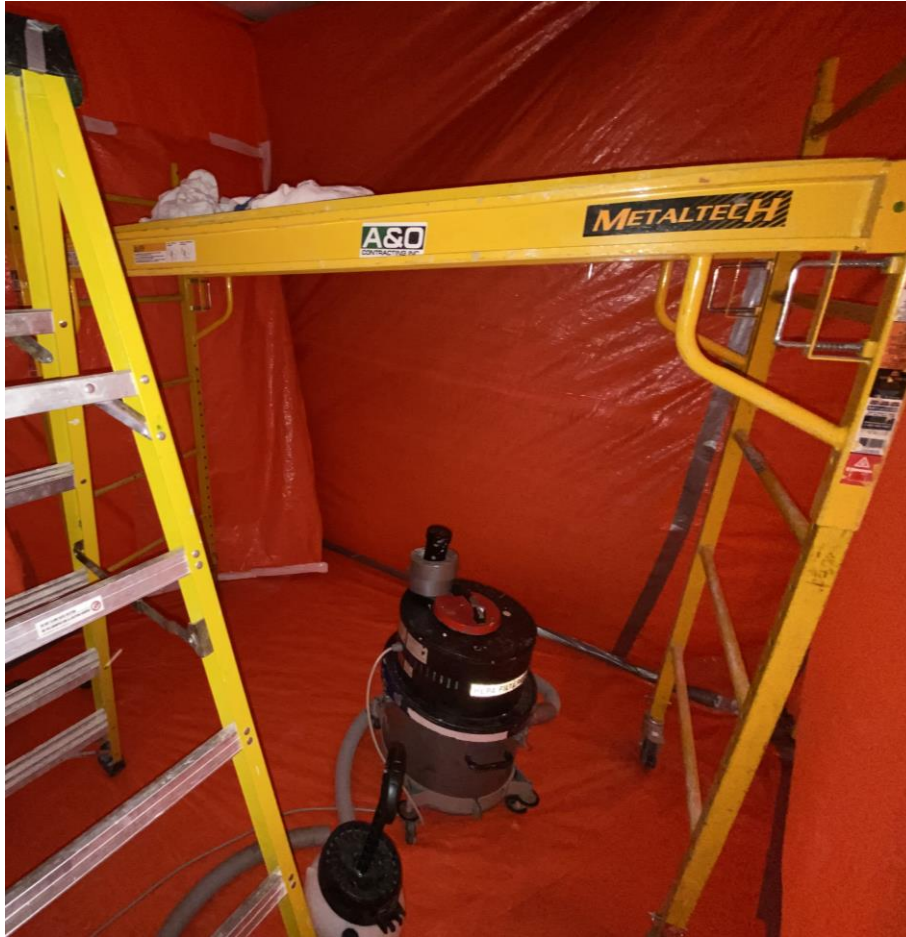
**Photograph 2:** View of the worker area and enclosure following Type 2 Operation procedures.
